Telecommunications  
Towers & Site Safety

ITSC: Wednesday September 14, 2005

# Site Safety

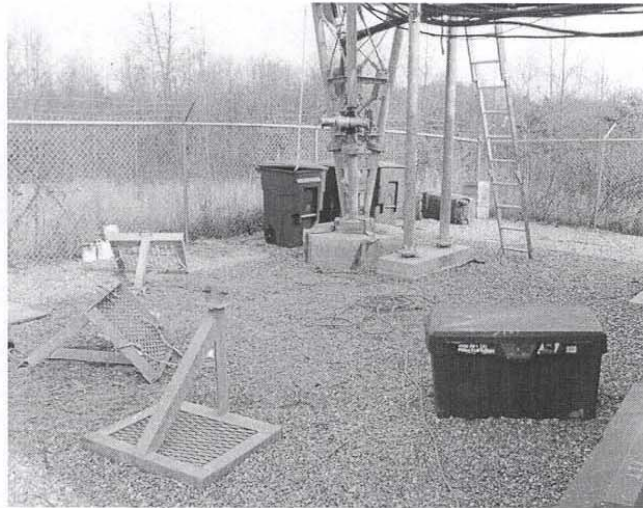
*Incident Site*

A 40-year-old tower-painting-company owner, his 16-year-old stepson, and a 19-year-old employee died after falling 1,200 feet when the hoist line on a portable capstan hoist used to raise them up the side of a 1,500-foot-high radio tower began slipping around the capstan, causing the hoist operator to lose control of the hoist line. The company had been at the site for 2 weeks to repair the beacon light at the top of the tower, paint the tower, and install rest platforms

on the tower. On the day of the incident, the owner was going to work on the beacon light at the top of the tower while the two other workers were going to continue painting the tower. A 3,000-foot length of  $\frac{3}{4}$ -inch nylon rope and a 1,000- pound-capacity portable electric capstan hoist was used to raise the male workers up the outside of the tower. Three loops, which the workers utilized to assist them in riding the hoist line, were tied into the hoist line approximately 6 feet apart. The stepson was first on the line, then the 19-year-old, then the company owner. Using a length of woven rope, the male workers had attached one of the rest platforms to the end of the nylon rope 62 inches below the

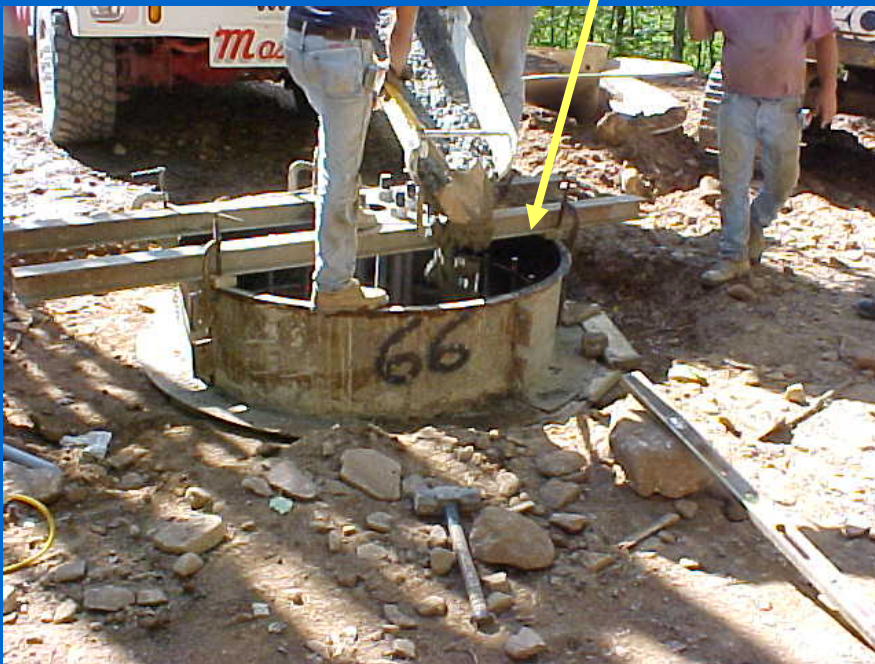
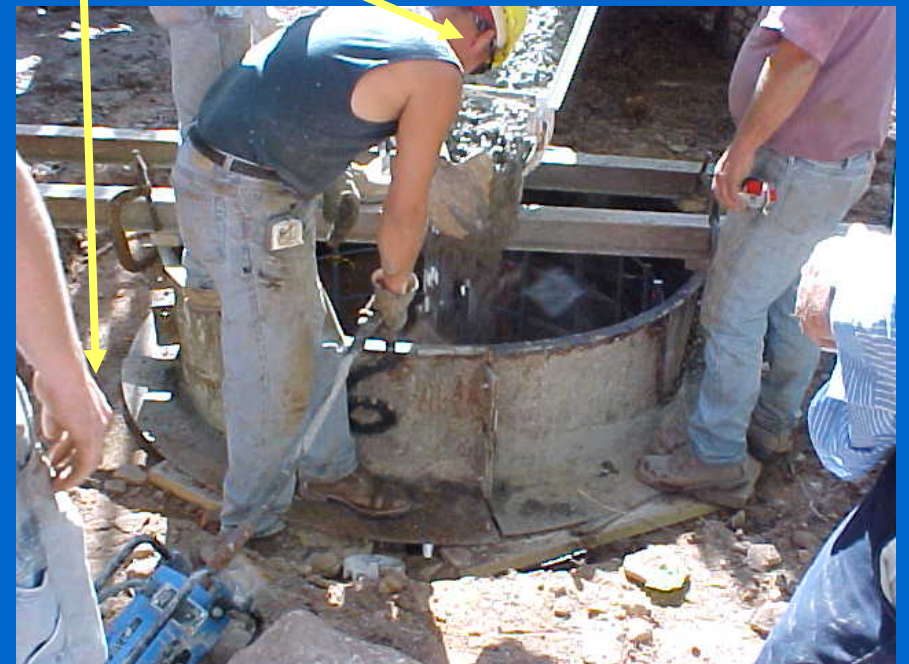
Where is the Tremie chute?

What about PPE?

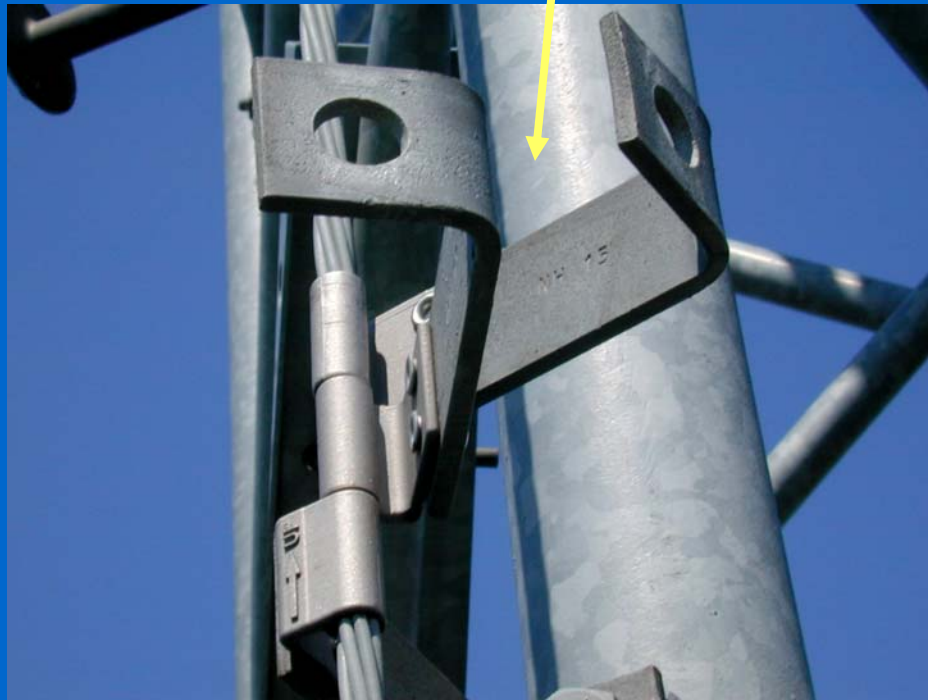
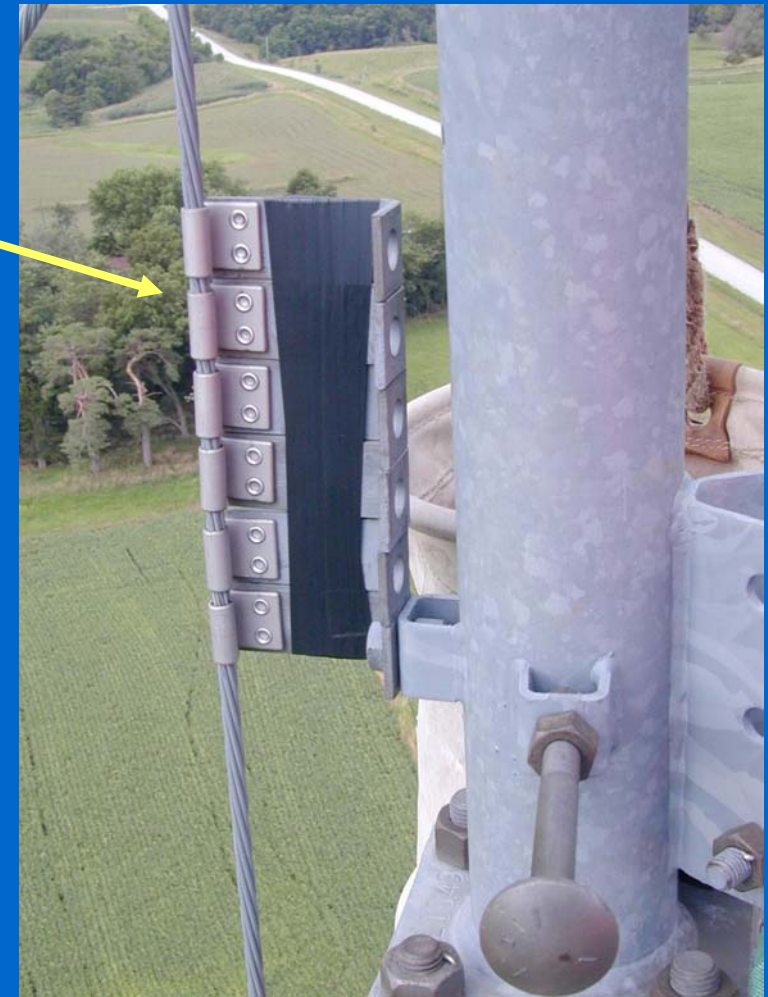
Improper install

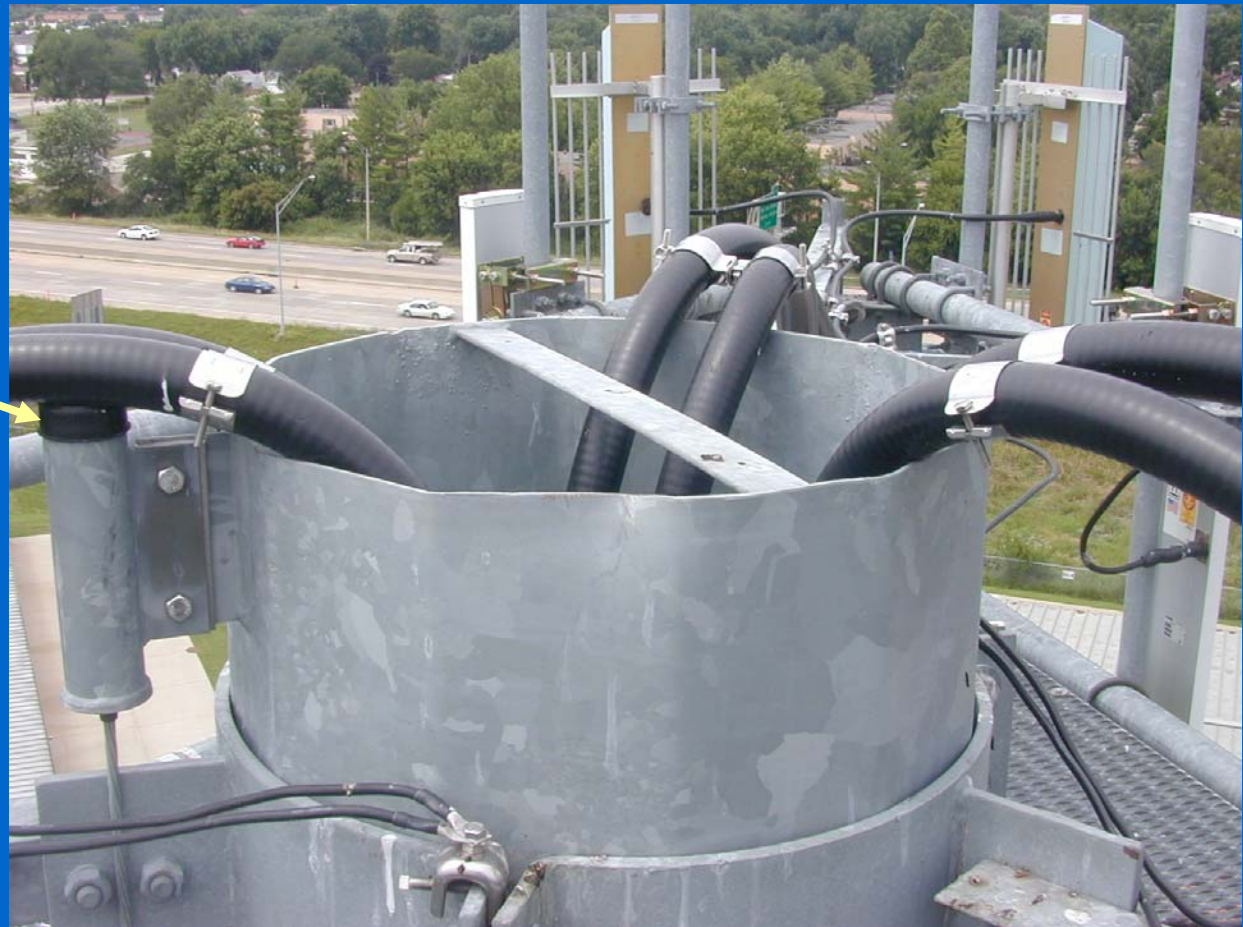
Very difficult  
to inspect

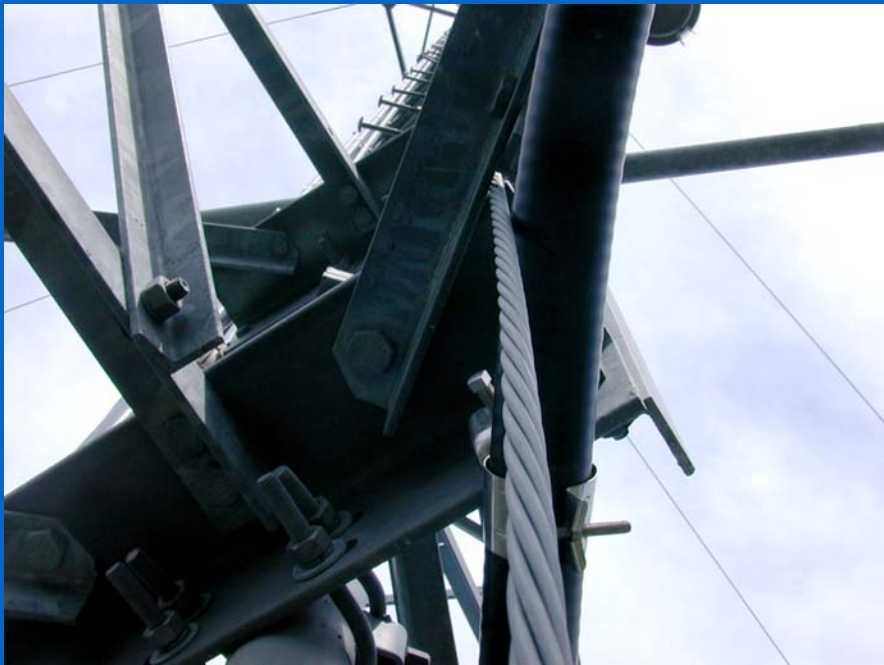
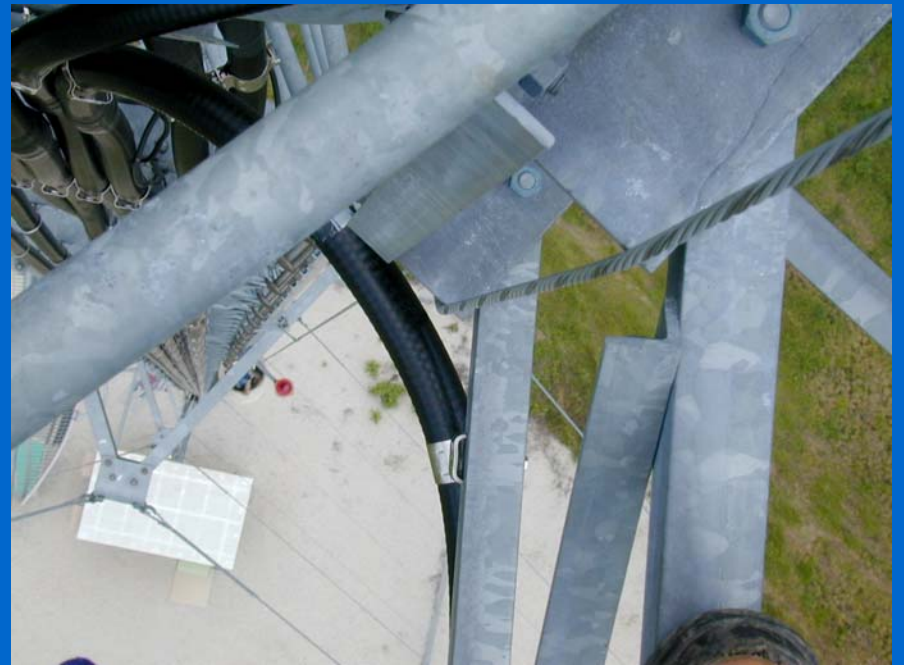
Mounts installed to render safe climb  
useless or unsafe

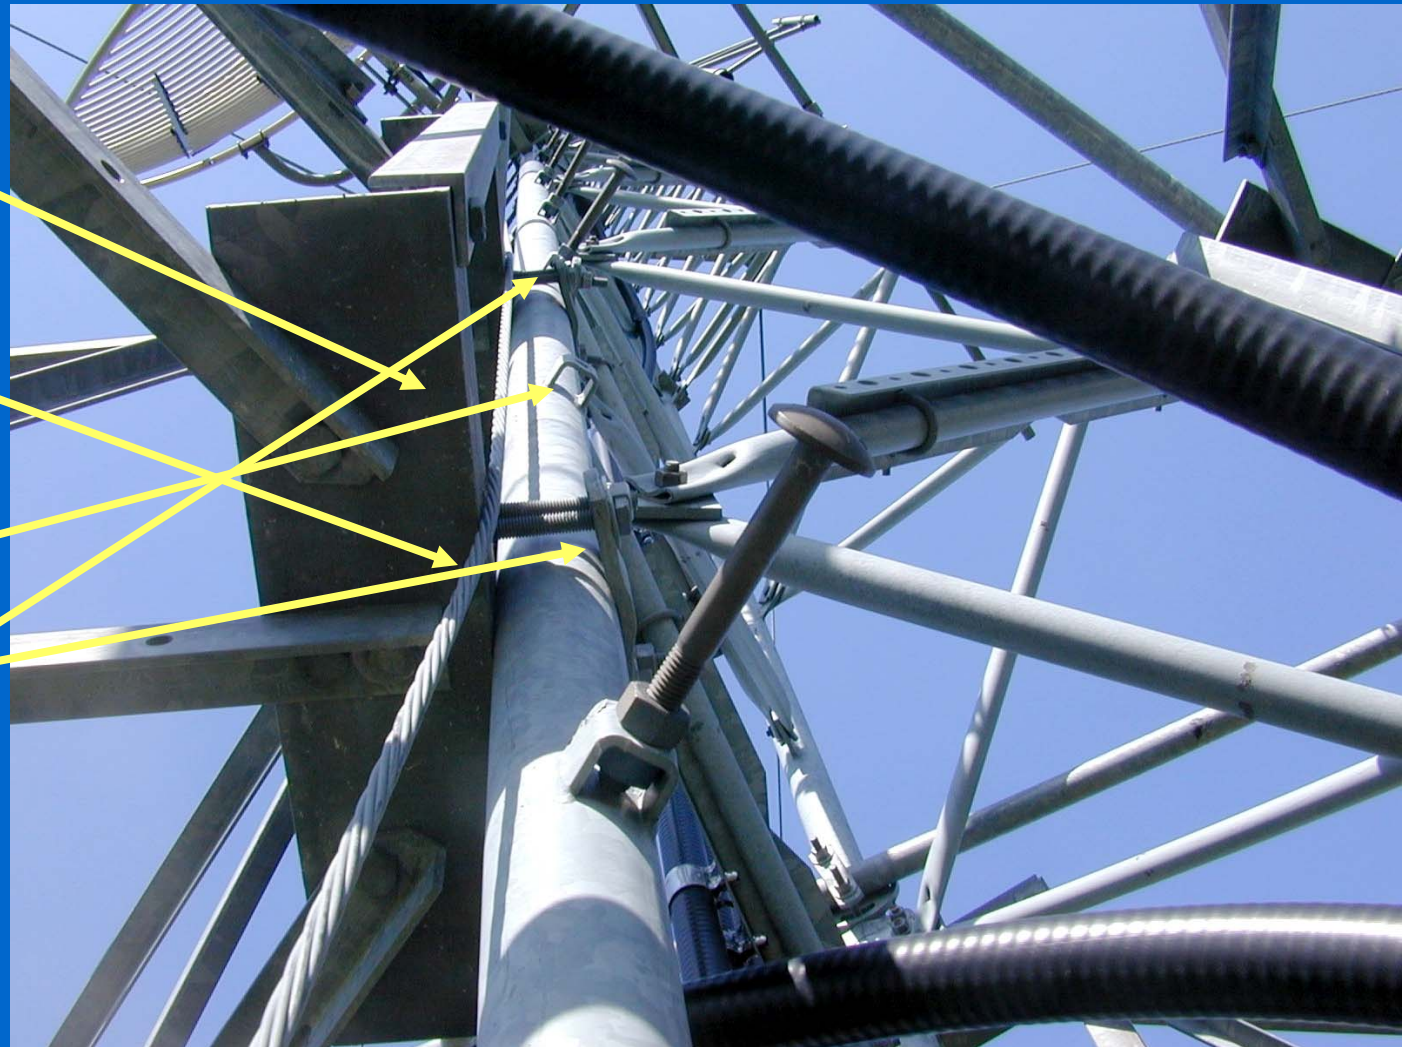
1. Obstruction
2. Improper tension applied to safe climb
3. Missing Step bolt
4. Improper hardware

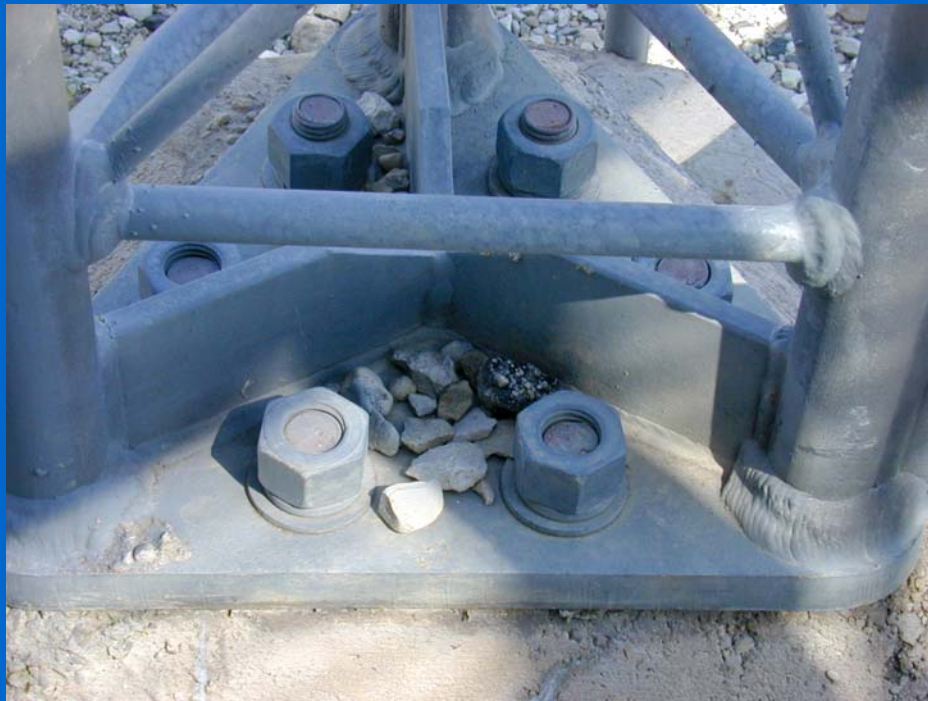
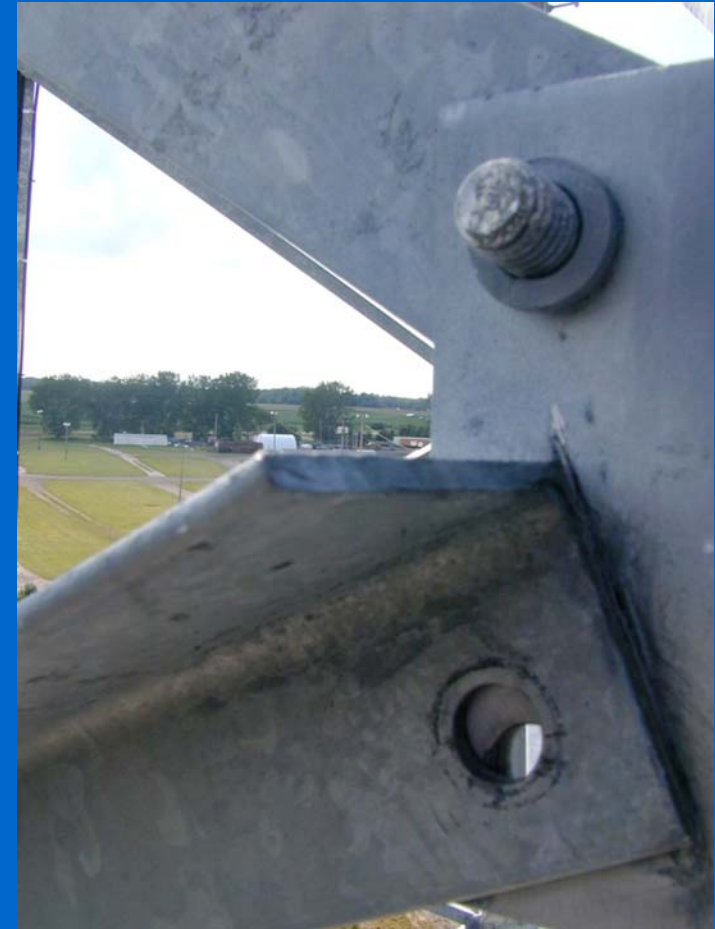
12% of the fatalities in this industry come from structural failure, most of them are due to improper initial install

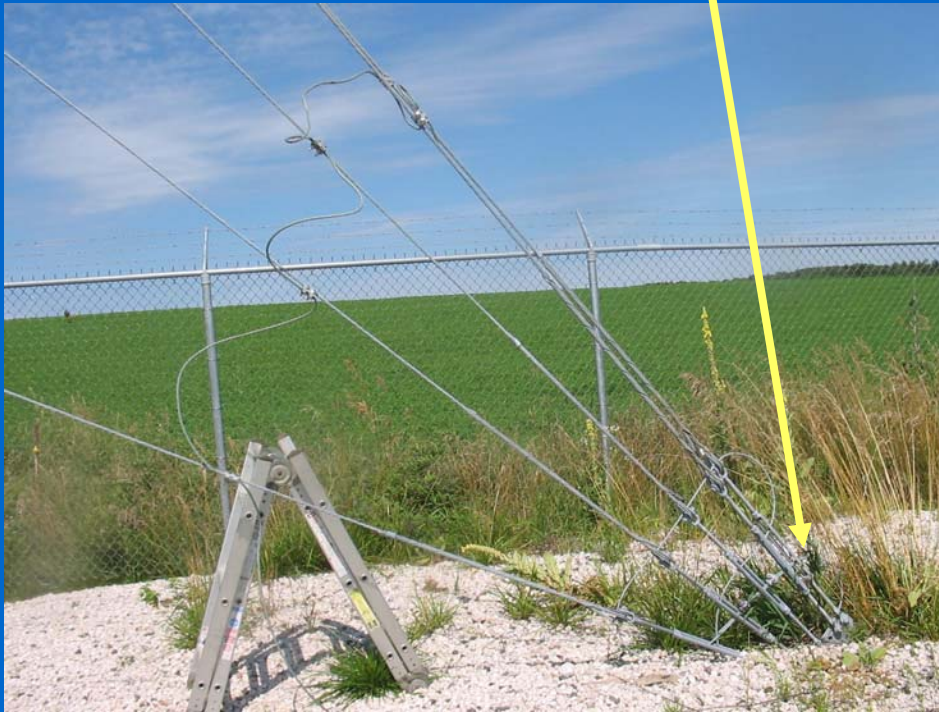
How do we inspect this?
