Safety Management

Mold Photos

Ken Shaw, CIH

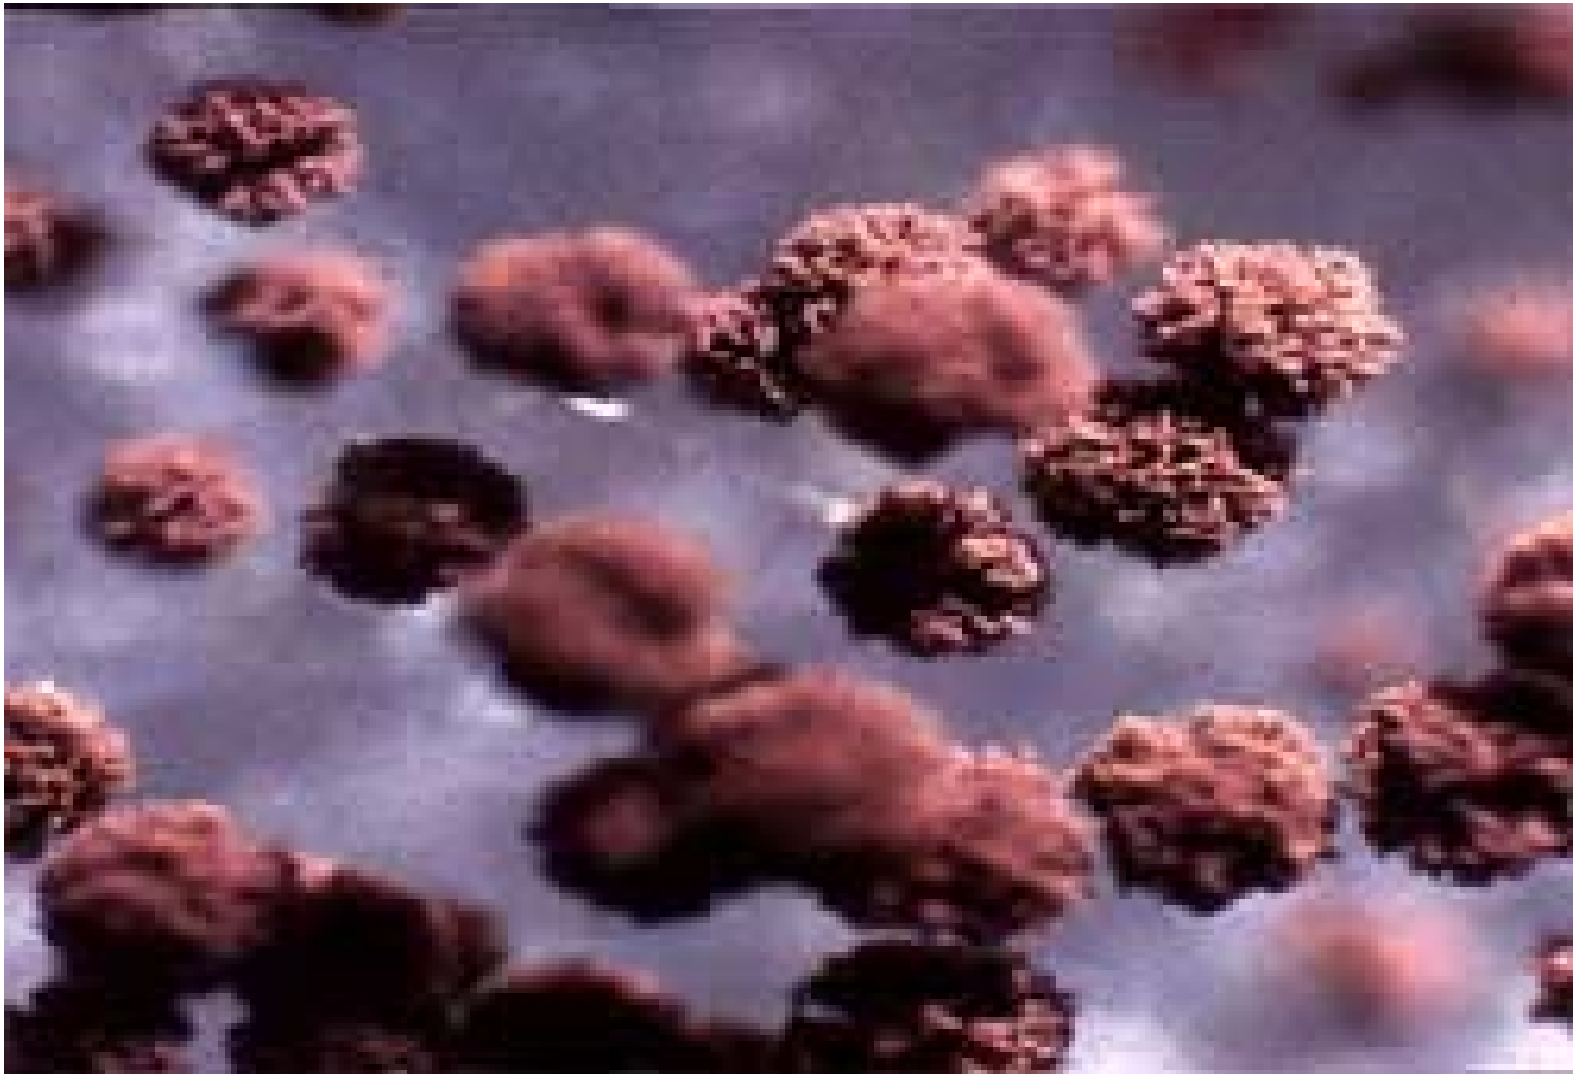
ASPERGILLUS

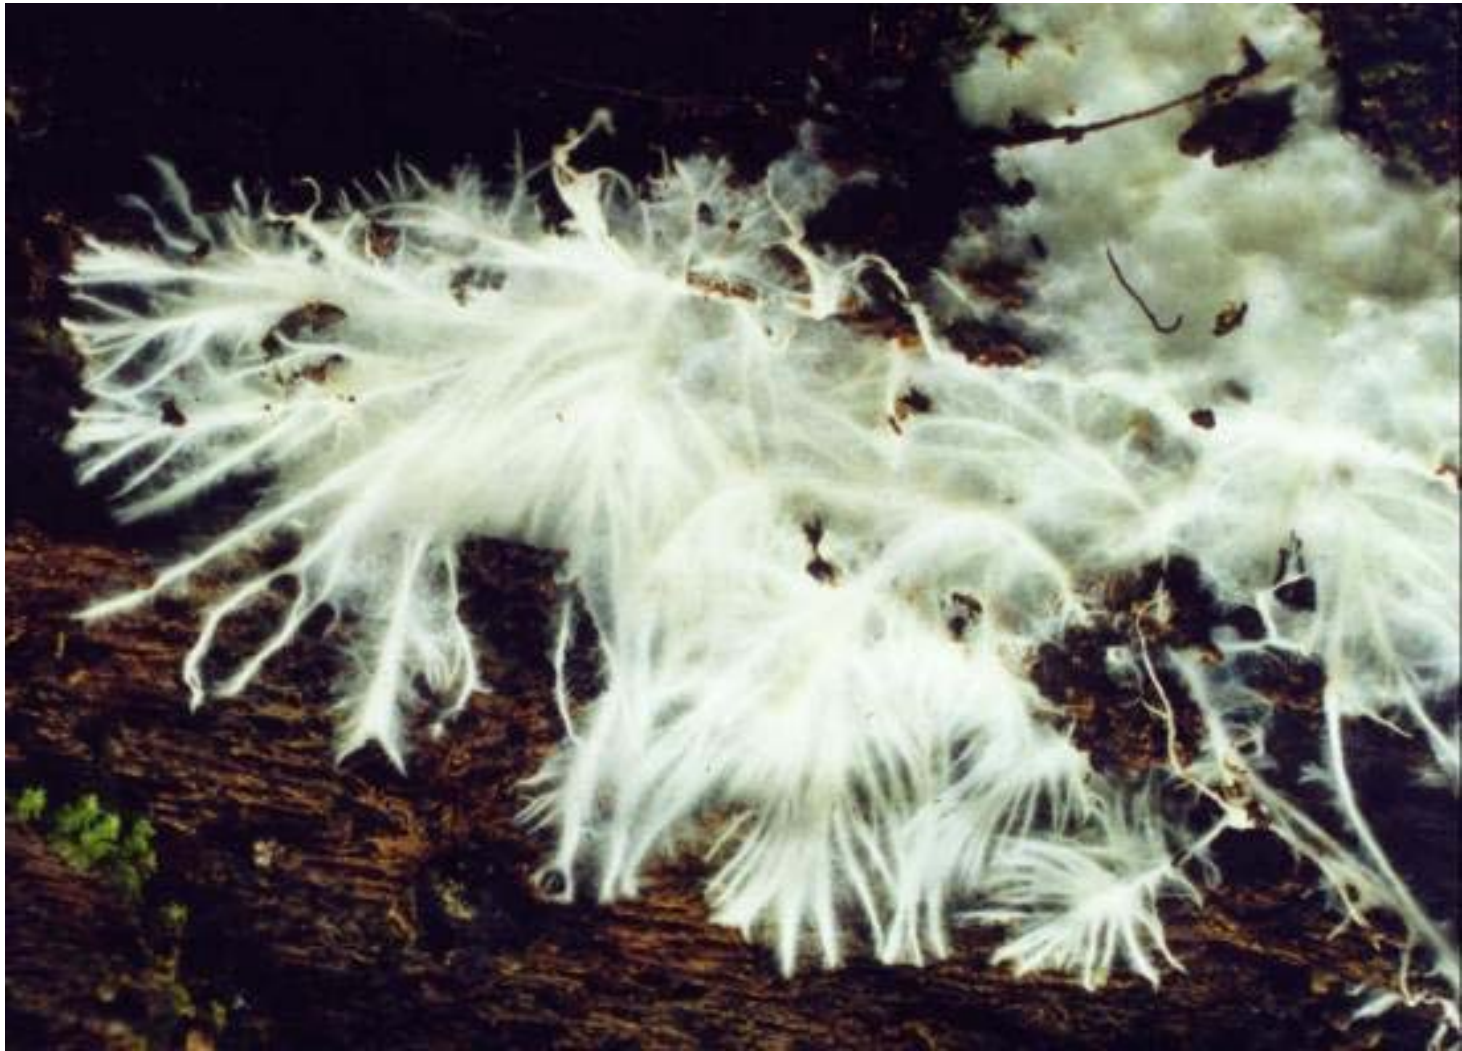
Mold showing filaments and typical woolly appearance

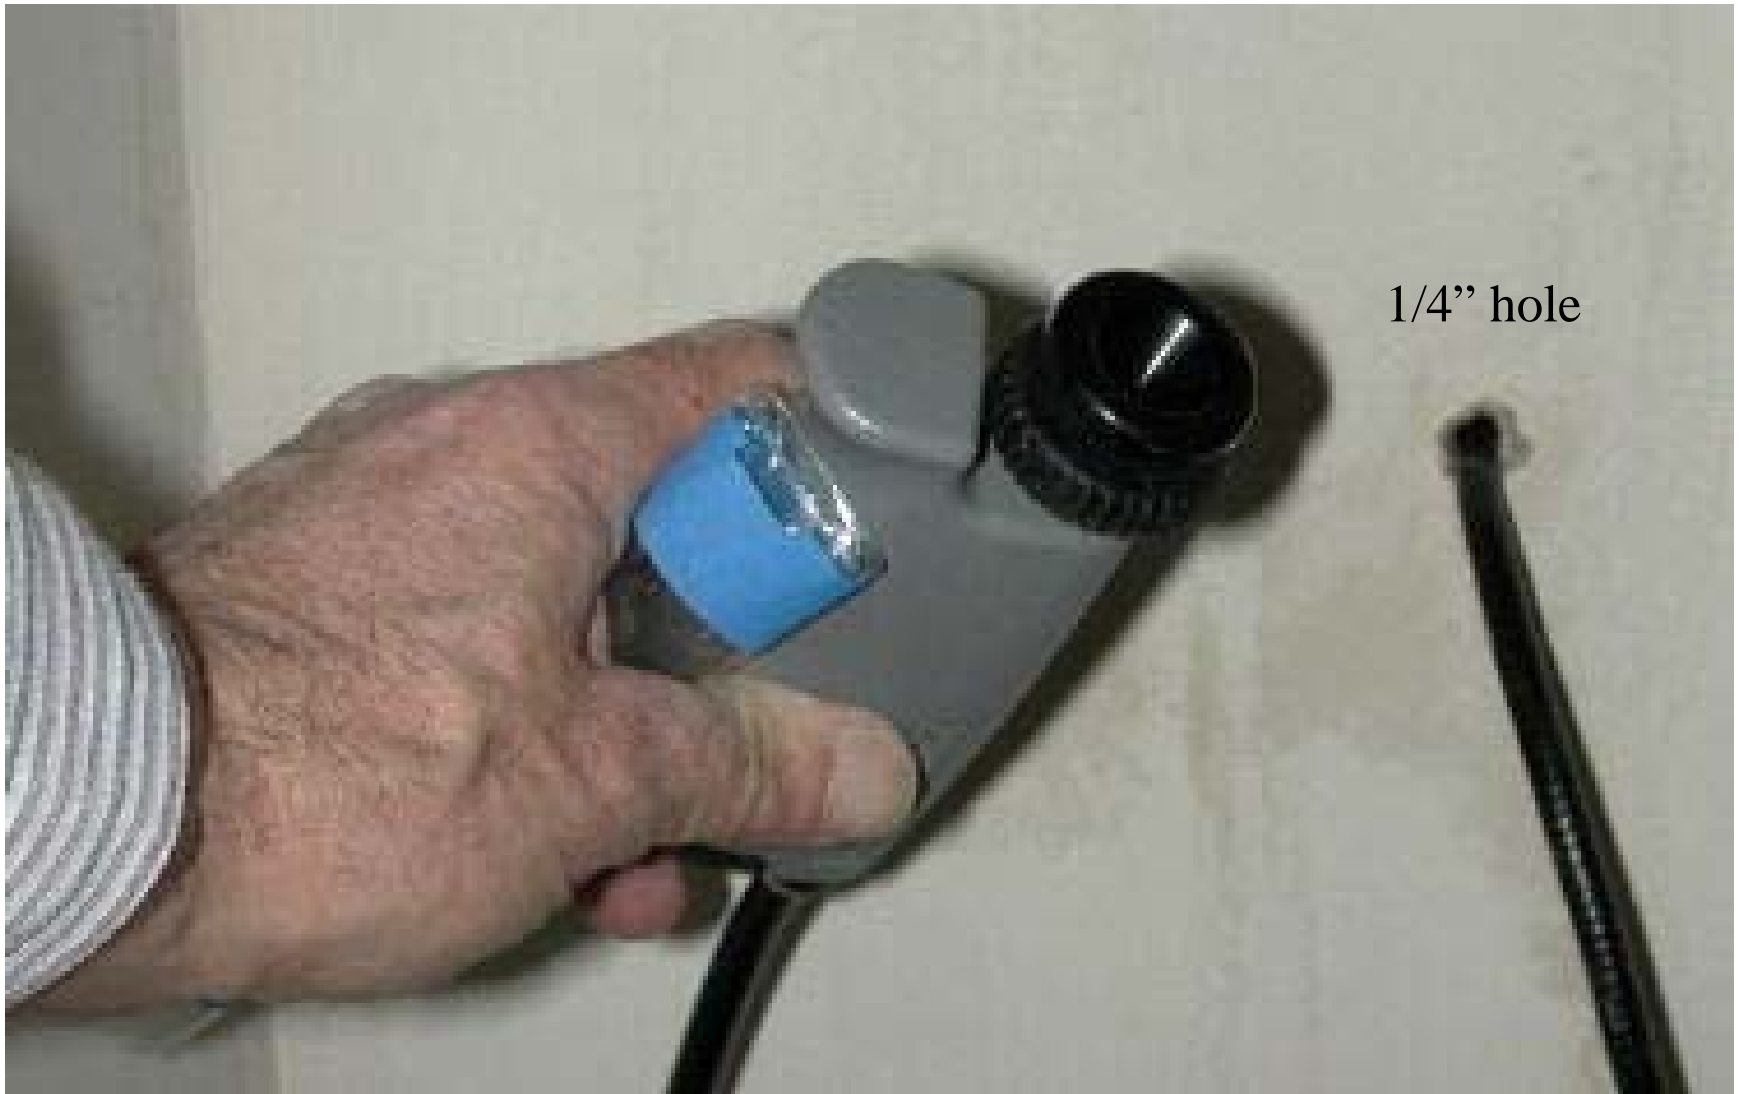
BORESCOPE - Used to inspect inside walls

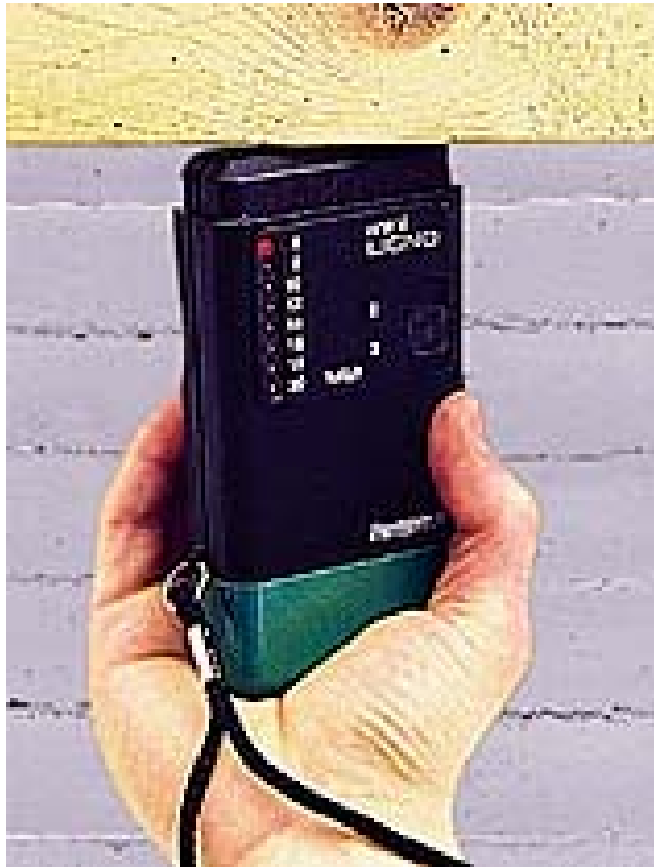
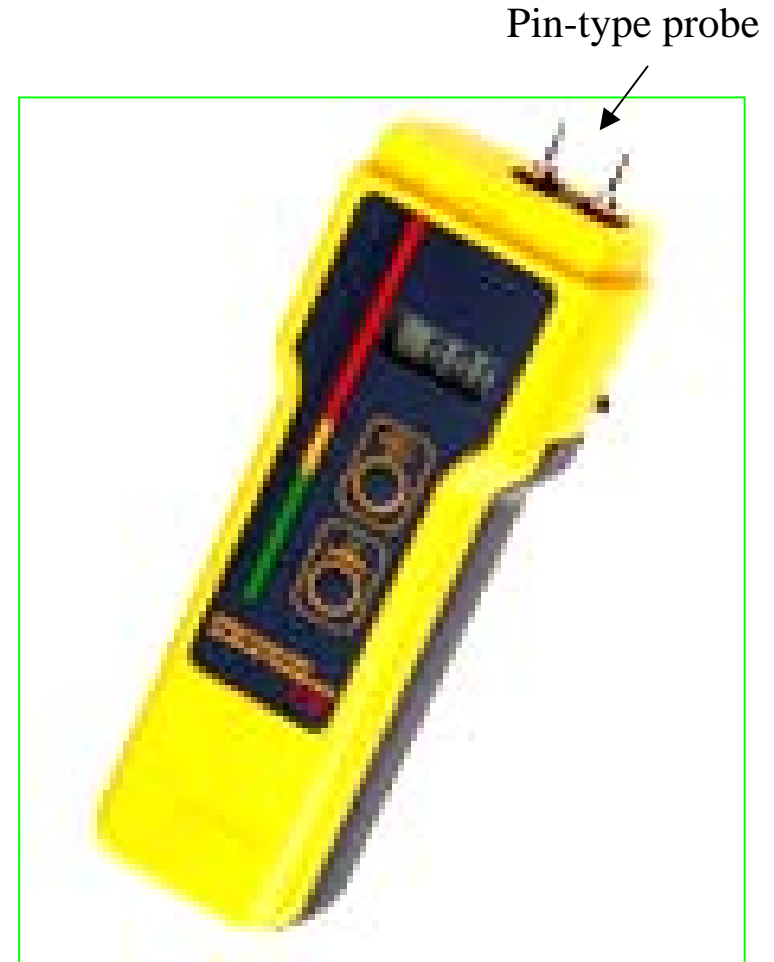
Moisture meters - Quantifies moisture content of solids

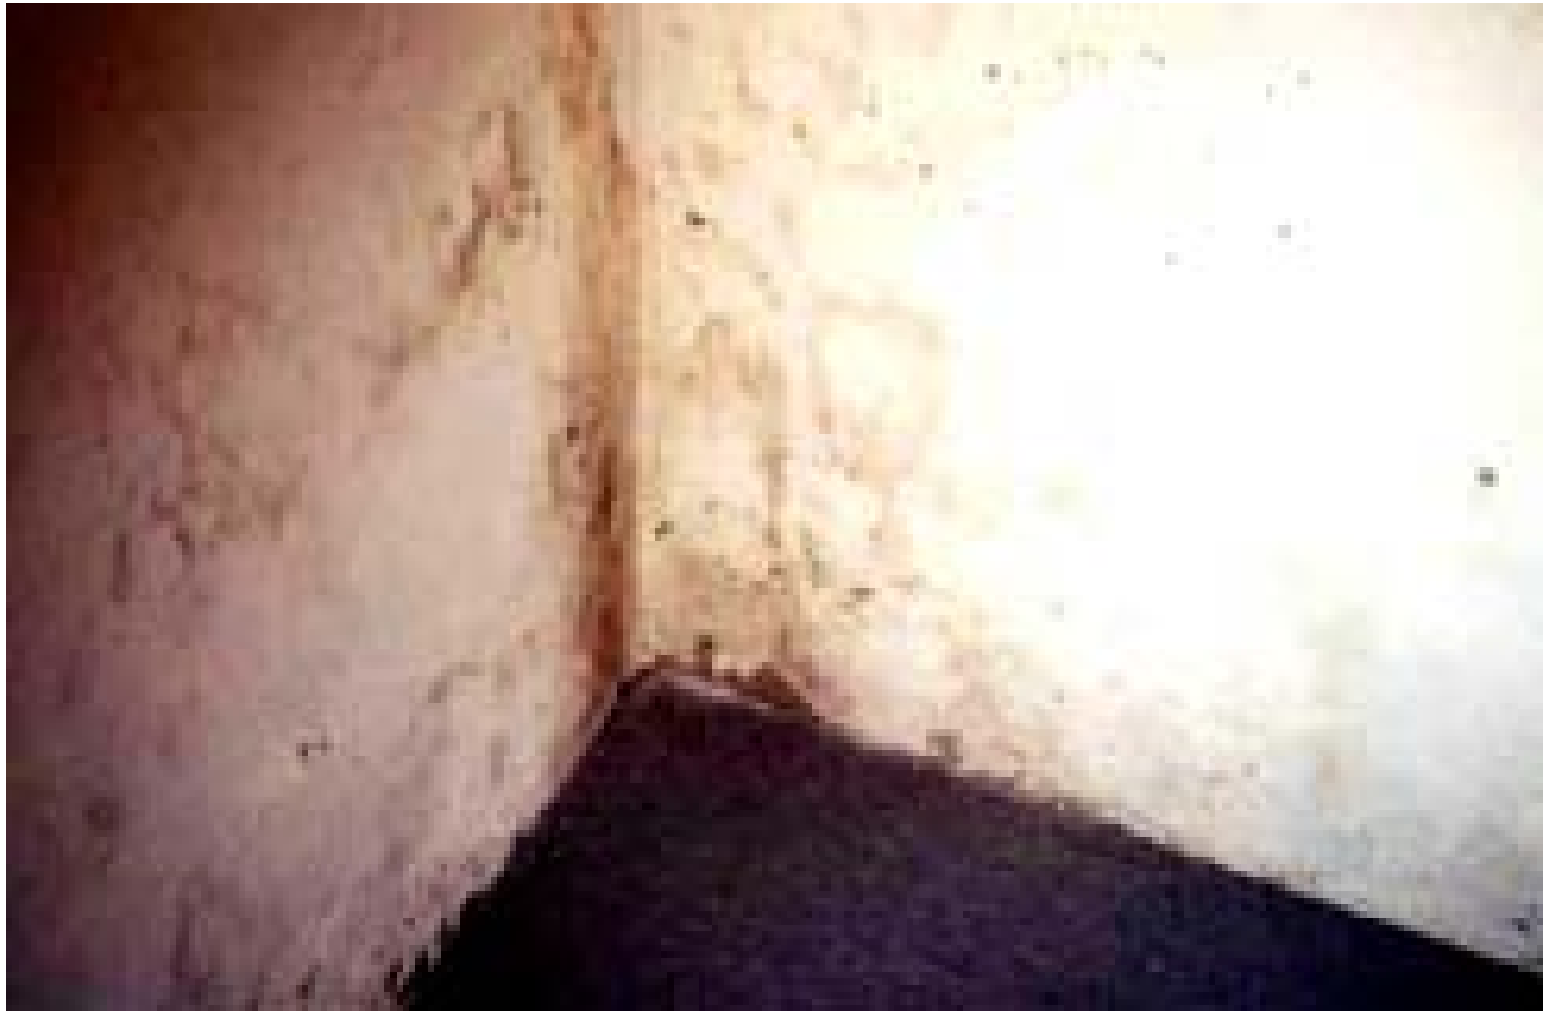
Mold growth in corner of a room (generic photo)

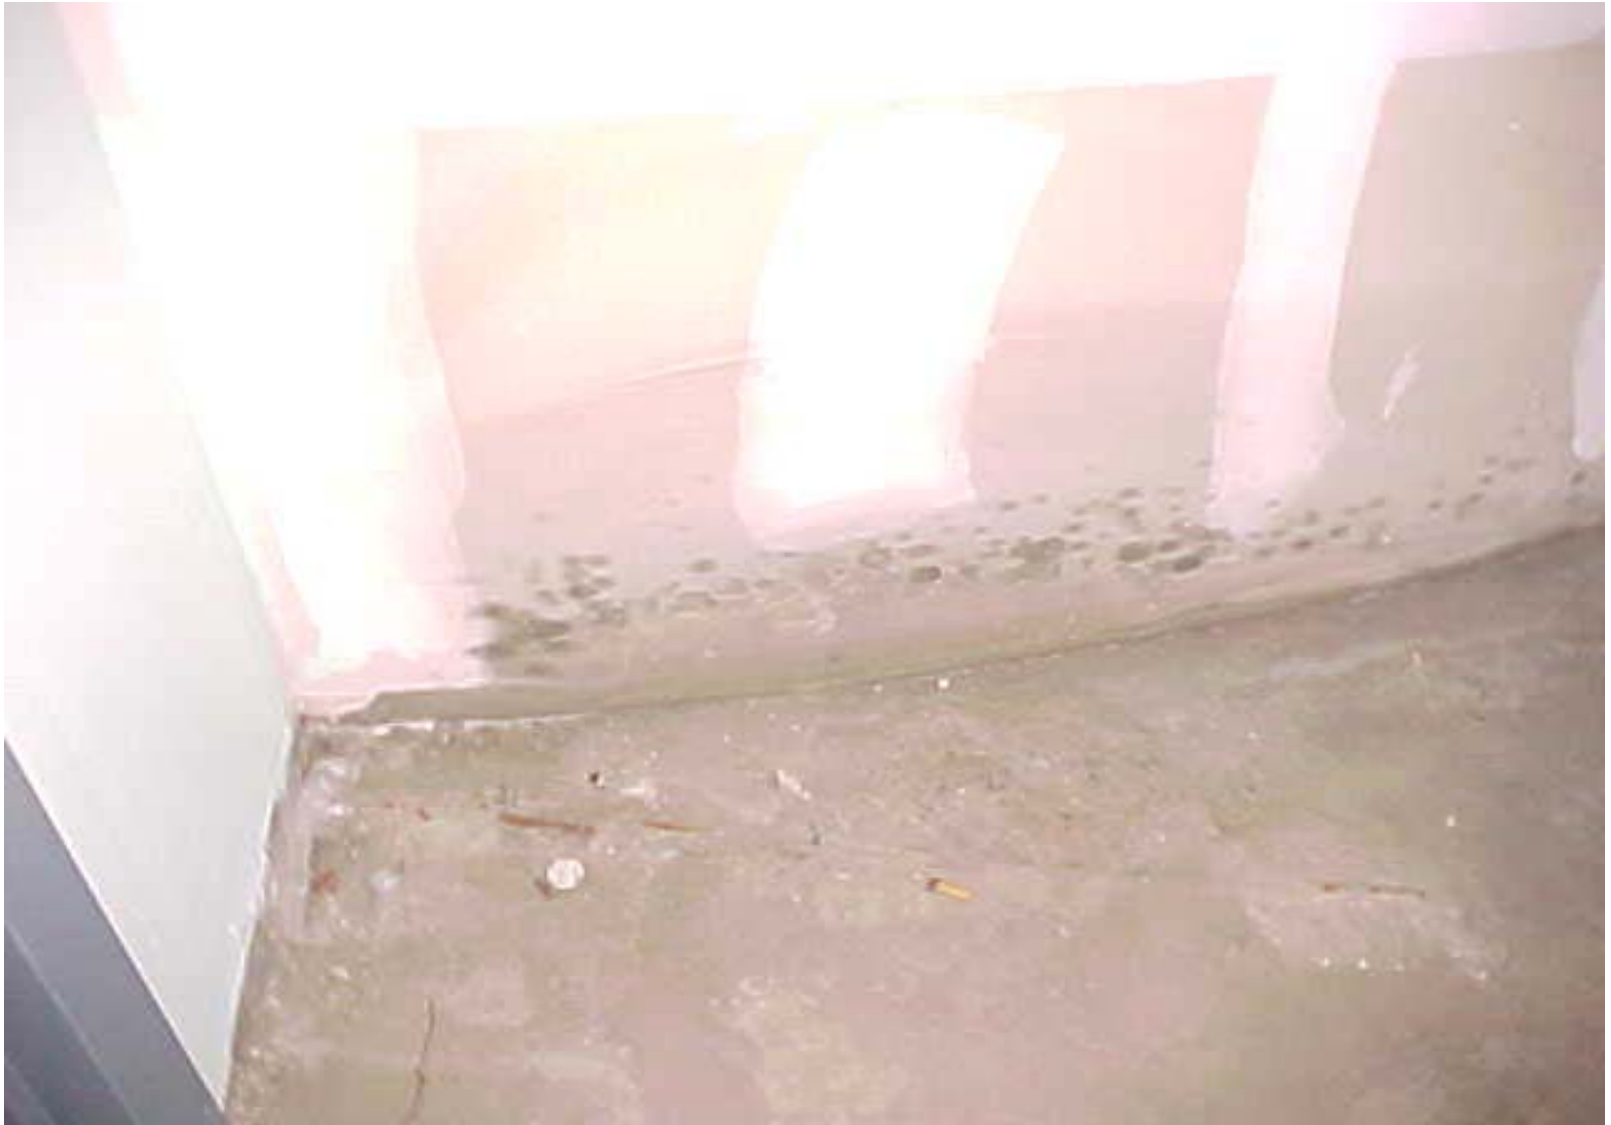
Mold Growth near floor level. What is the moisture source?

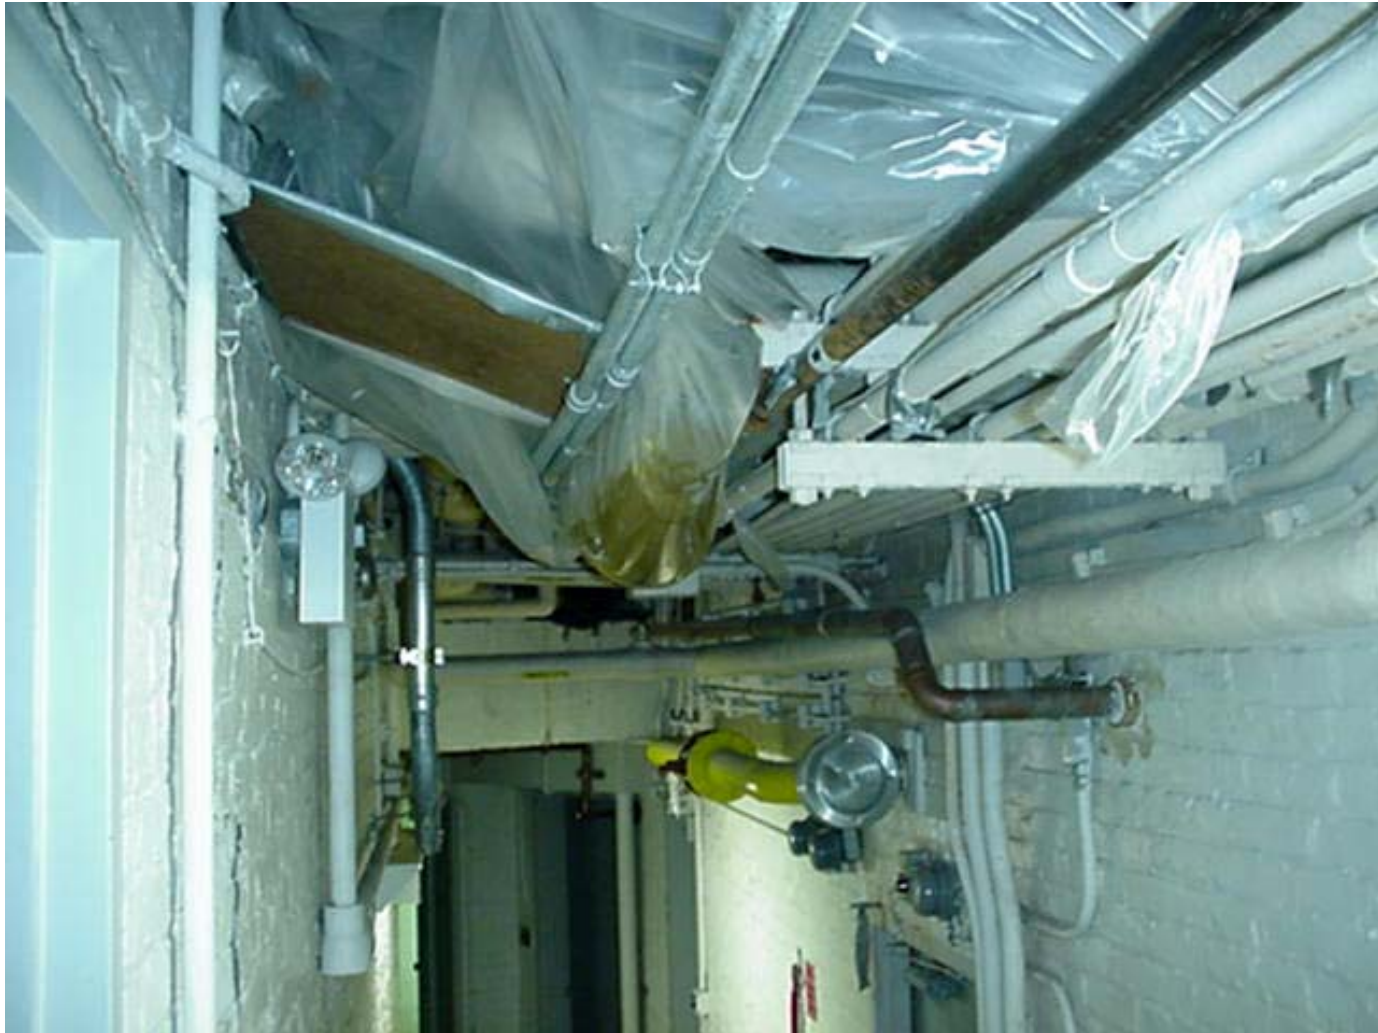
Long-term water leak. Plastic with water accumulation.

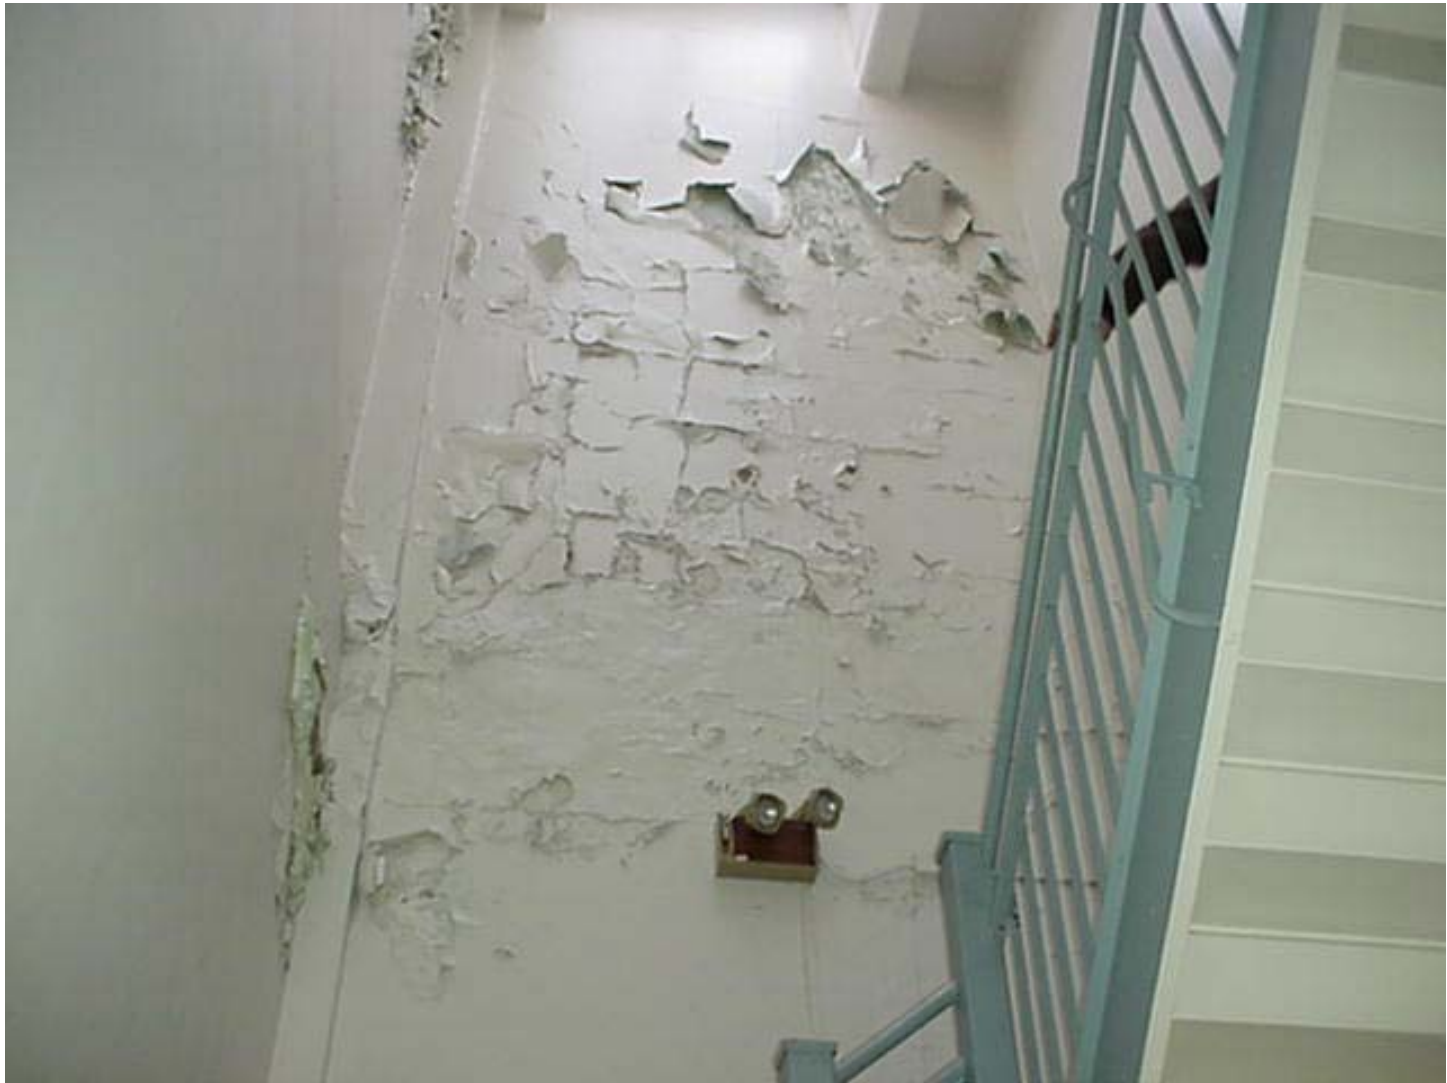
Peeling Paint - Indicative of moisture/water migration

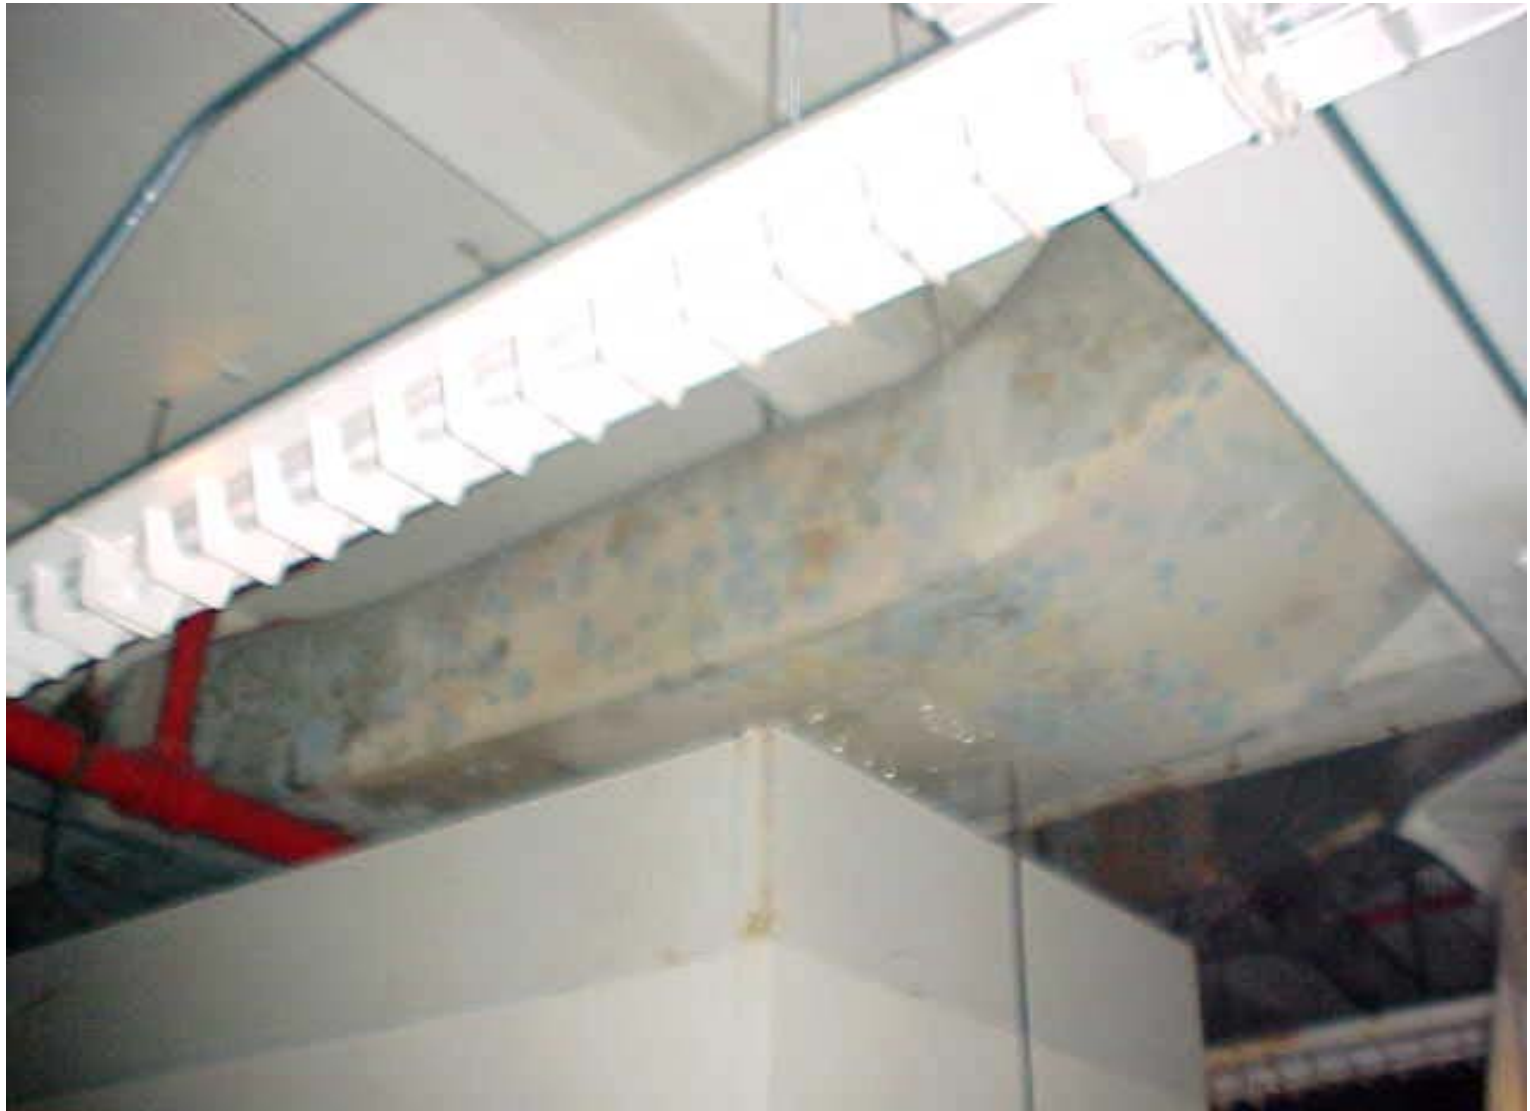
Mold on ventilation duct exterior

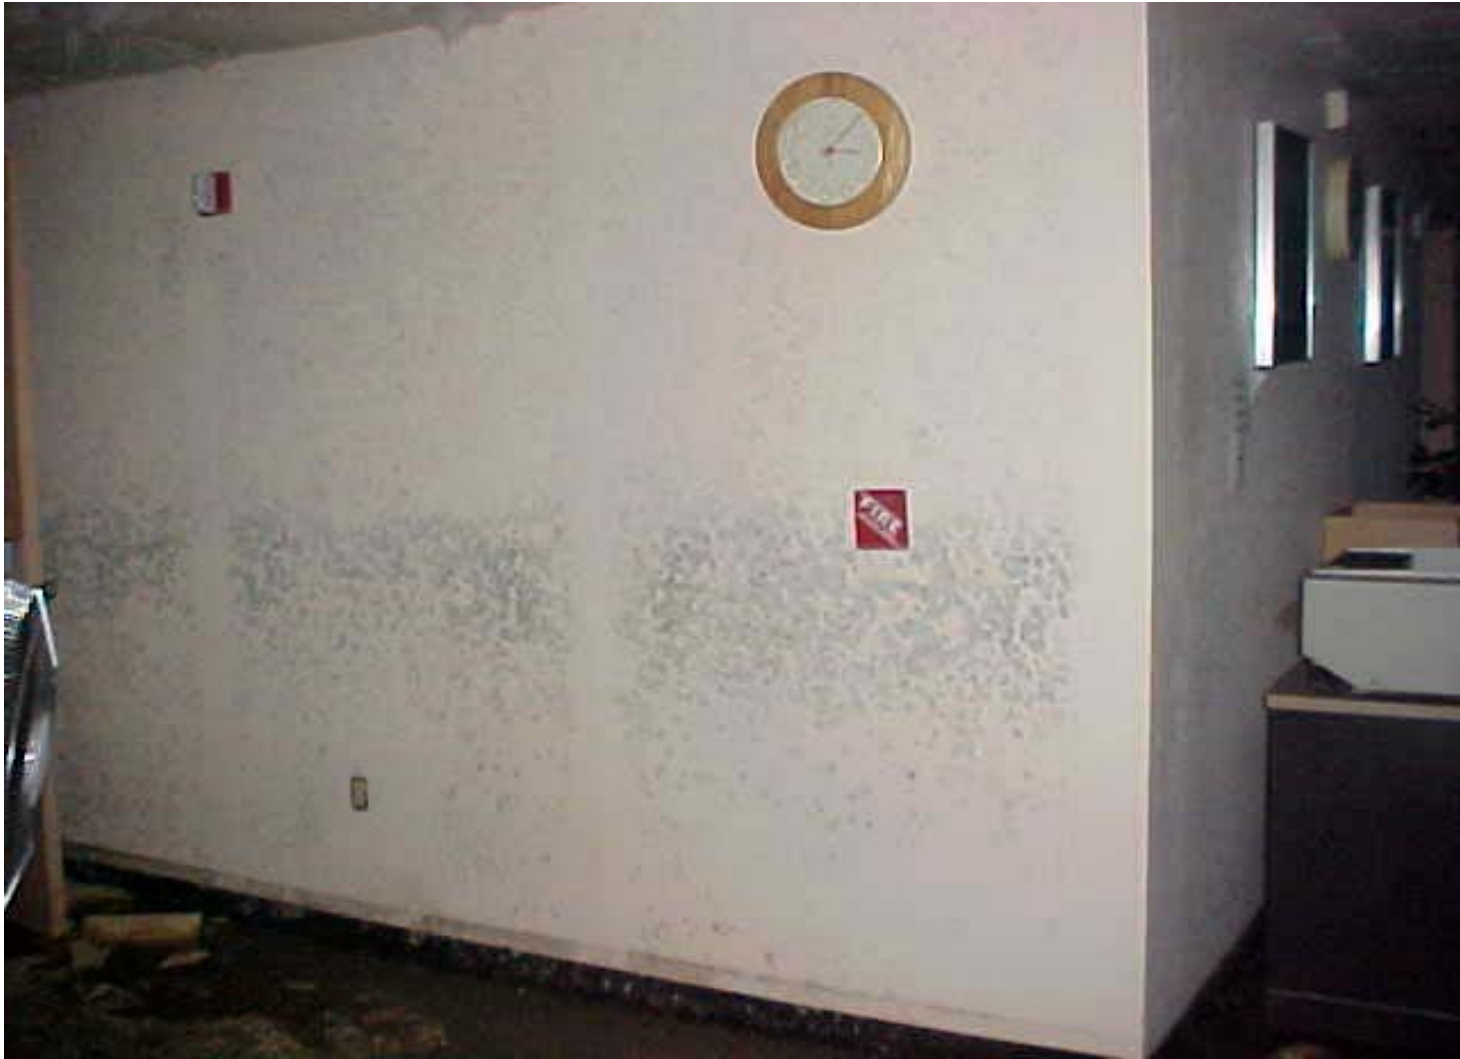
Mold on wall after a flood - 3 weeks of growth

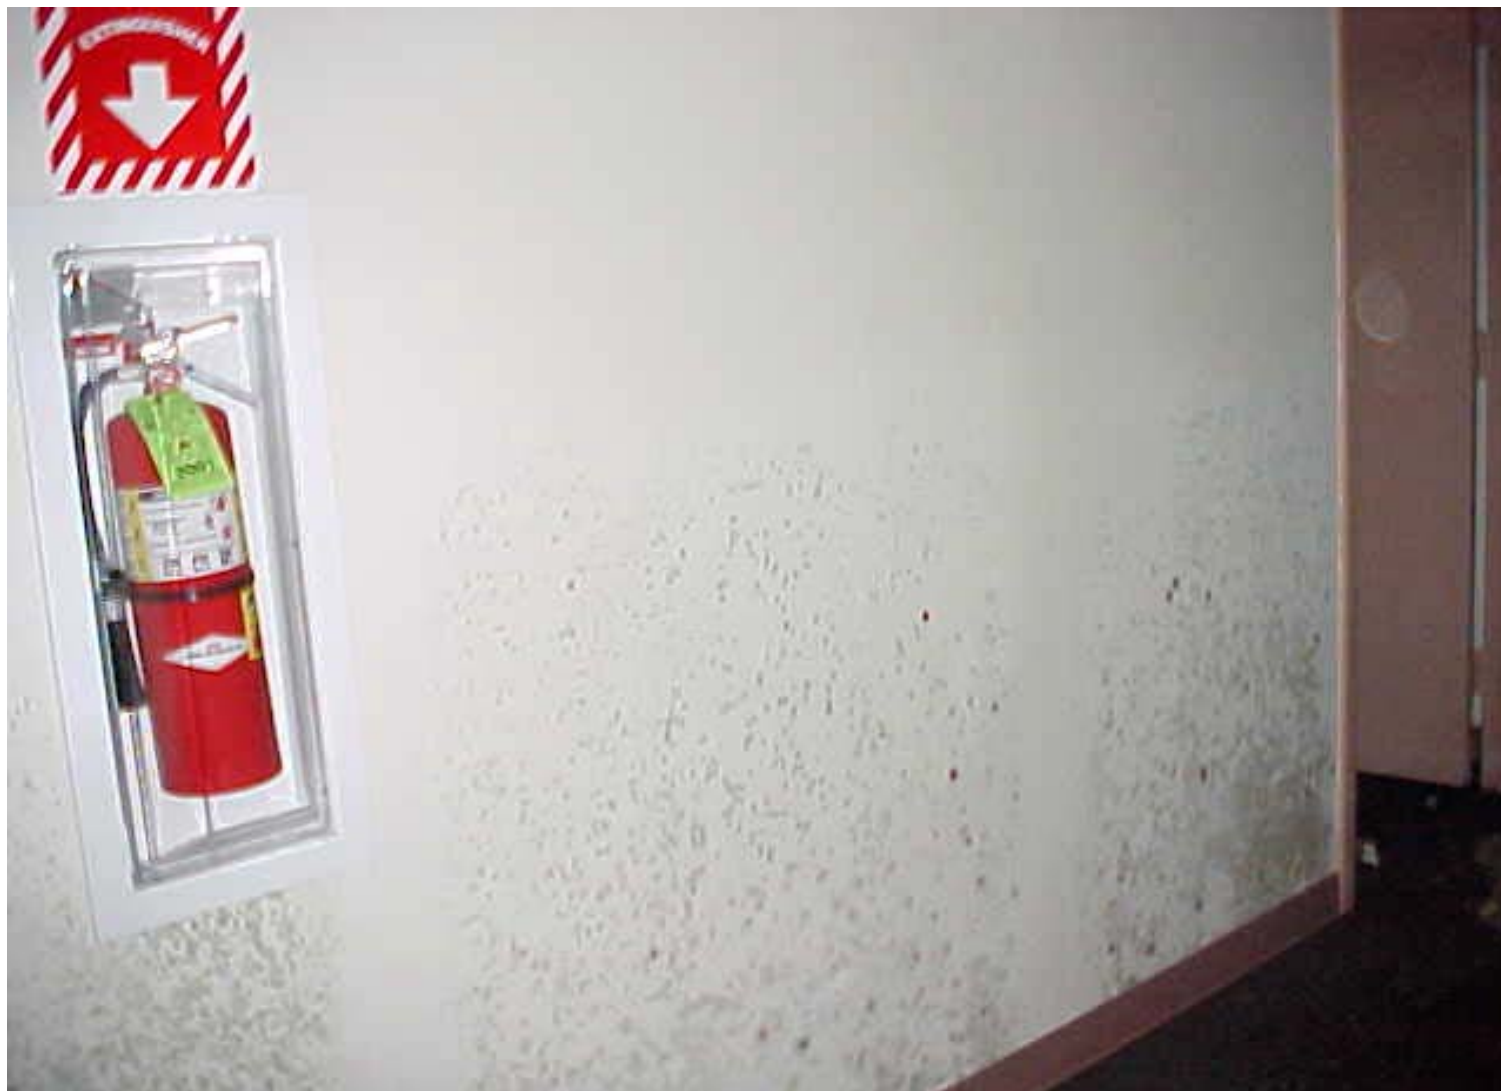
Mold growth on wall board - flooded basement

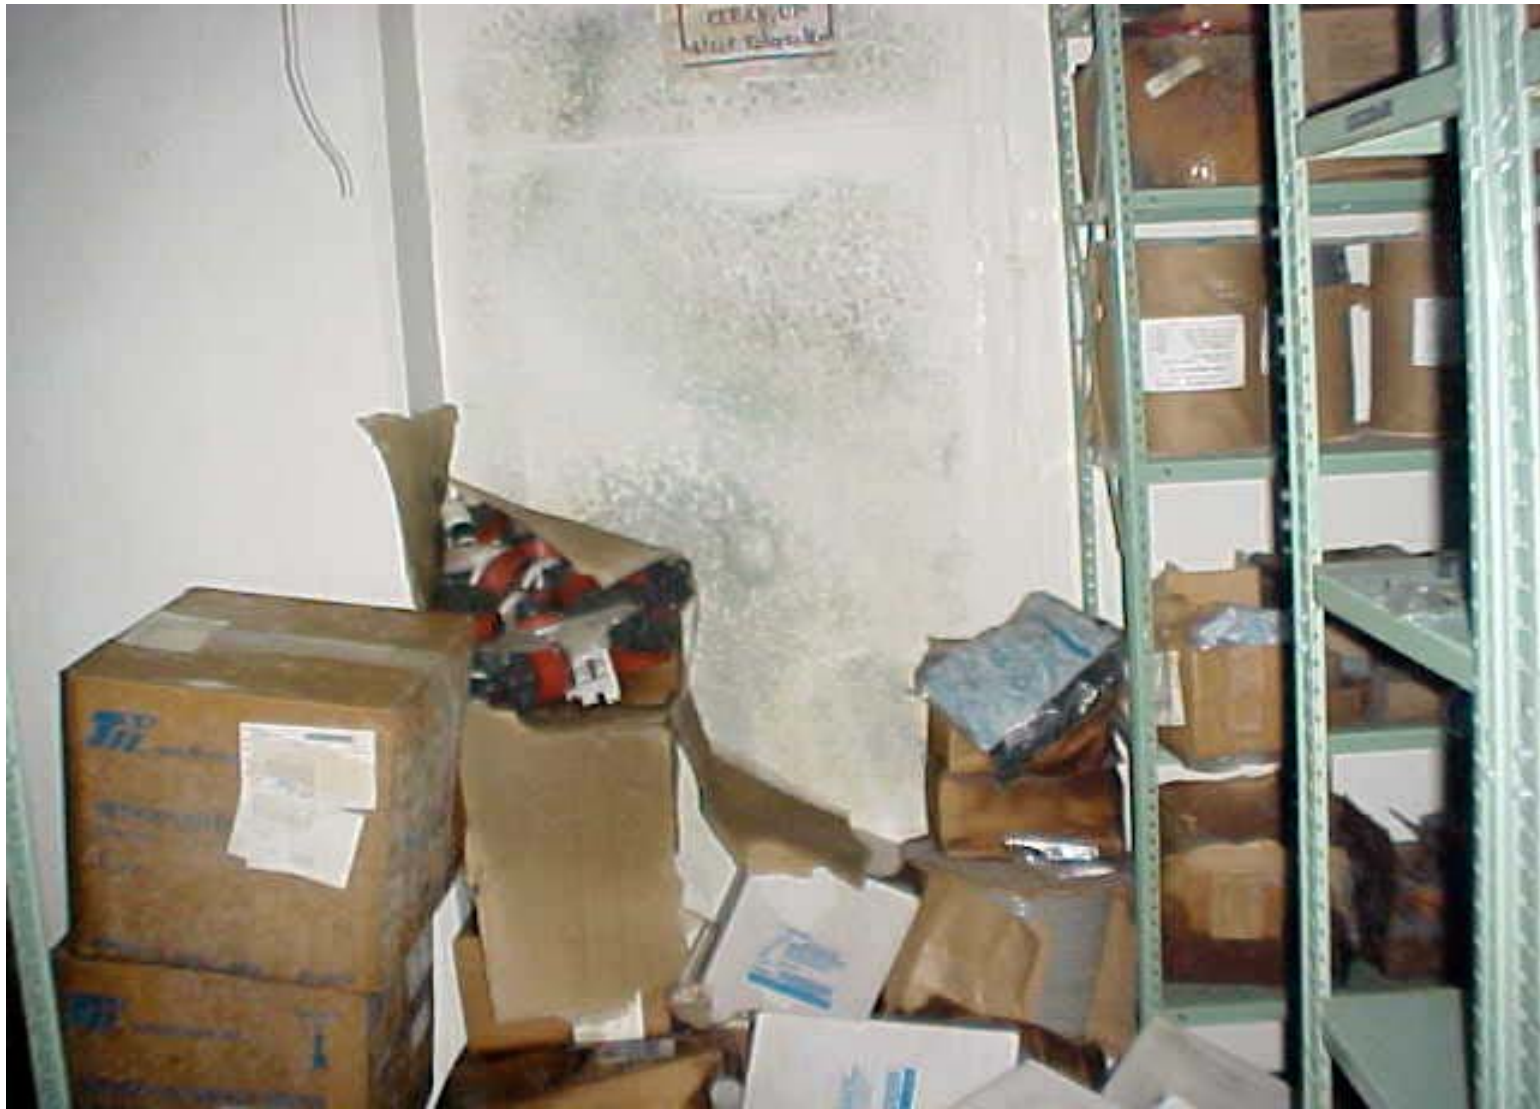
Storage room in basement - 3 weeks of mold growth

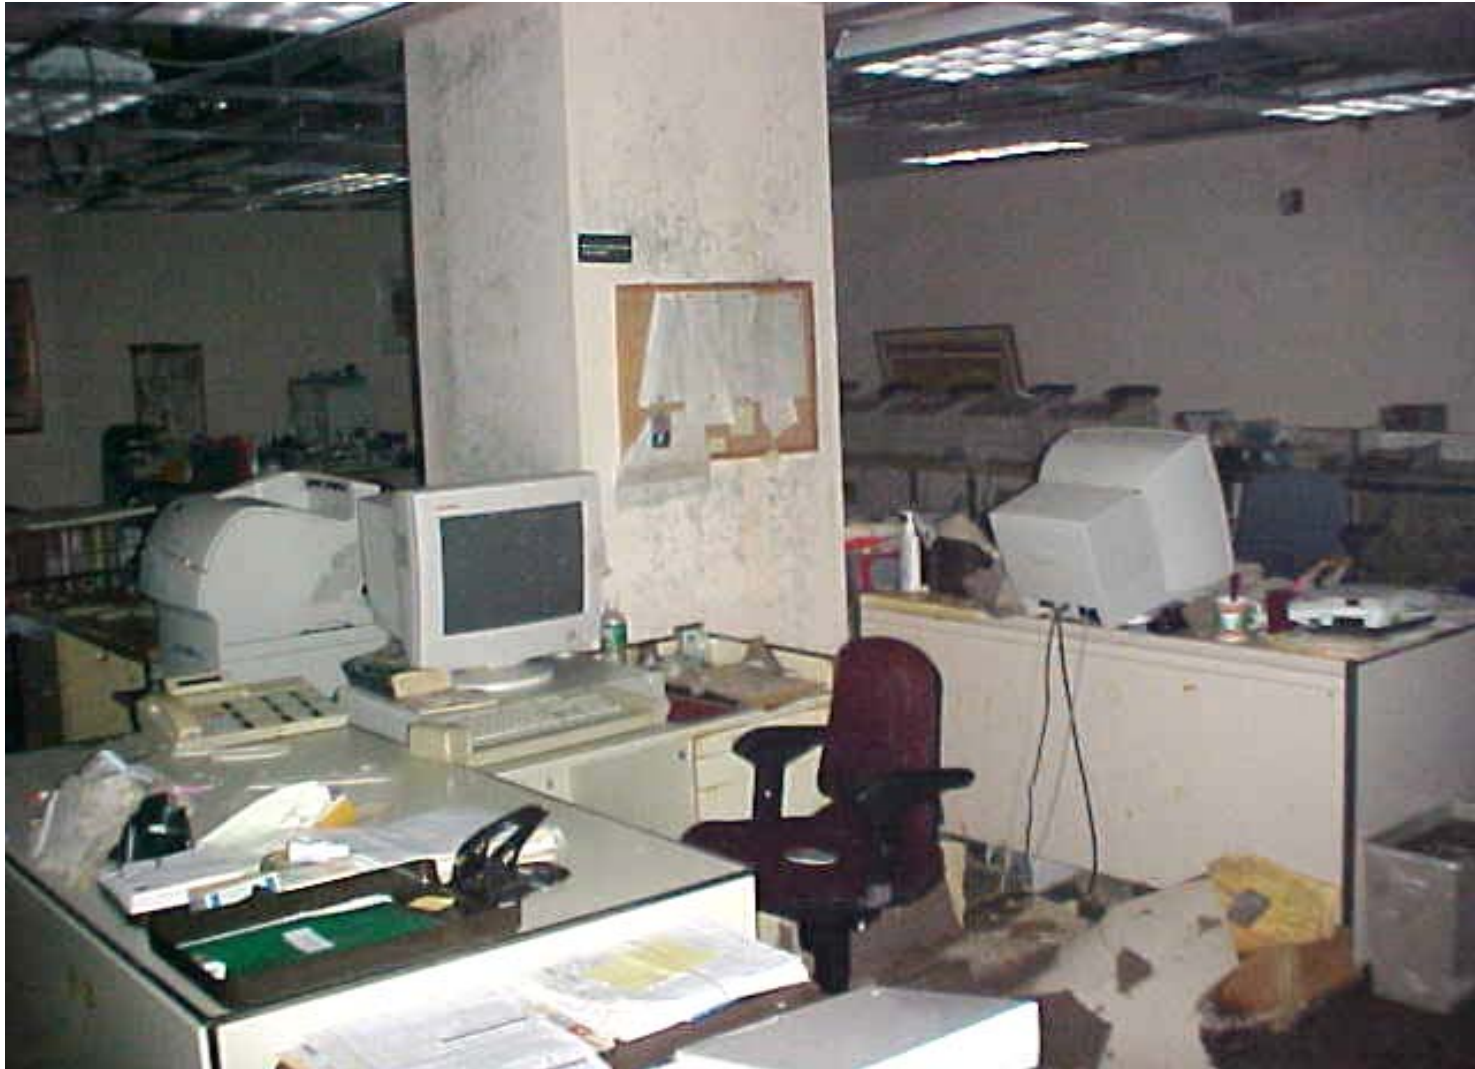
Mold on column and other surfaces - flooded basement

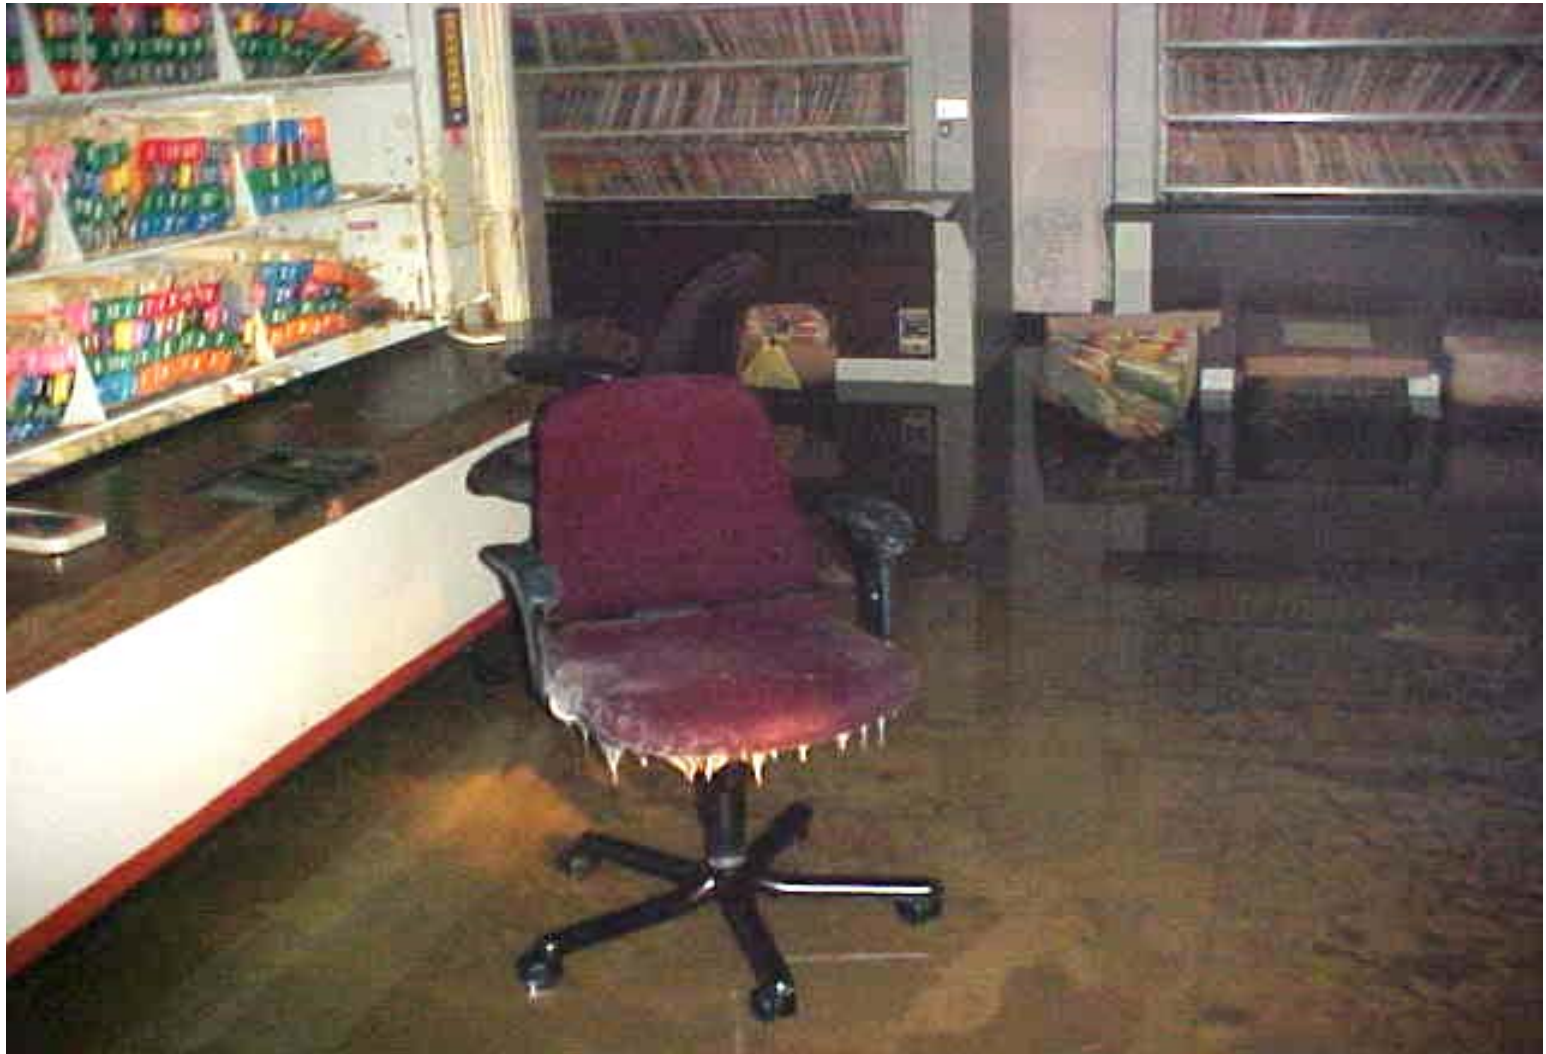
Moldy chair and medical records - basement after a flood
