Safety Management

Mold Photos

Ken Shaw, CIH

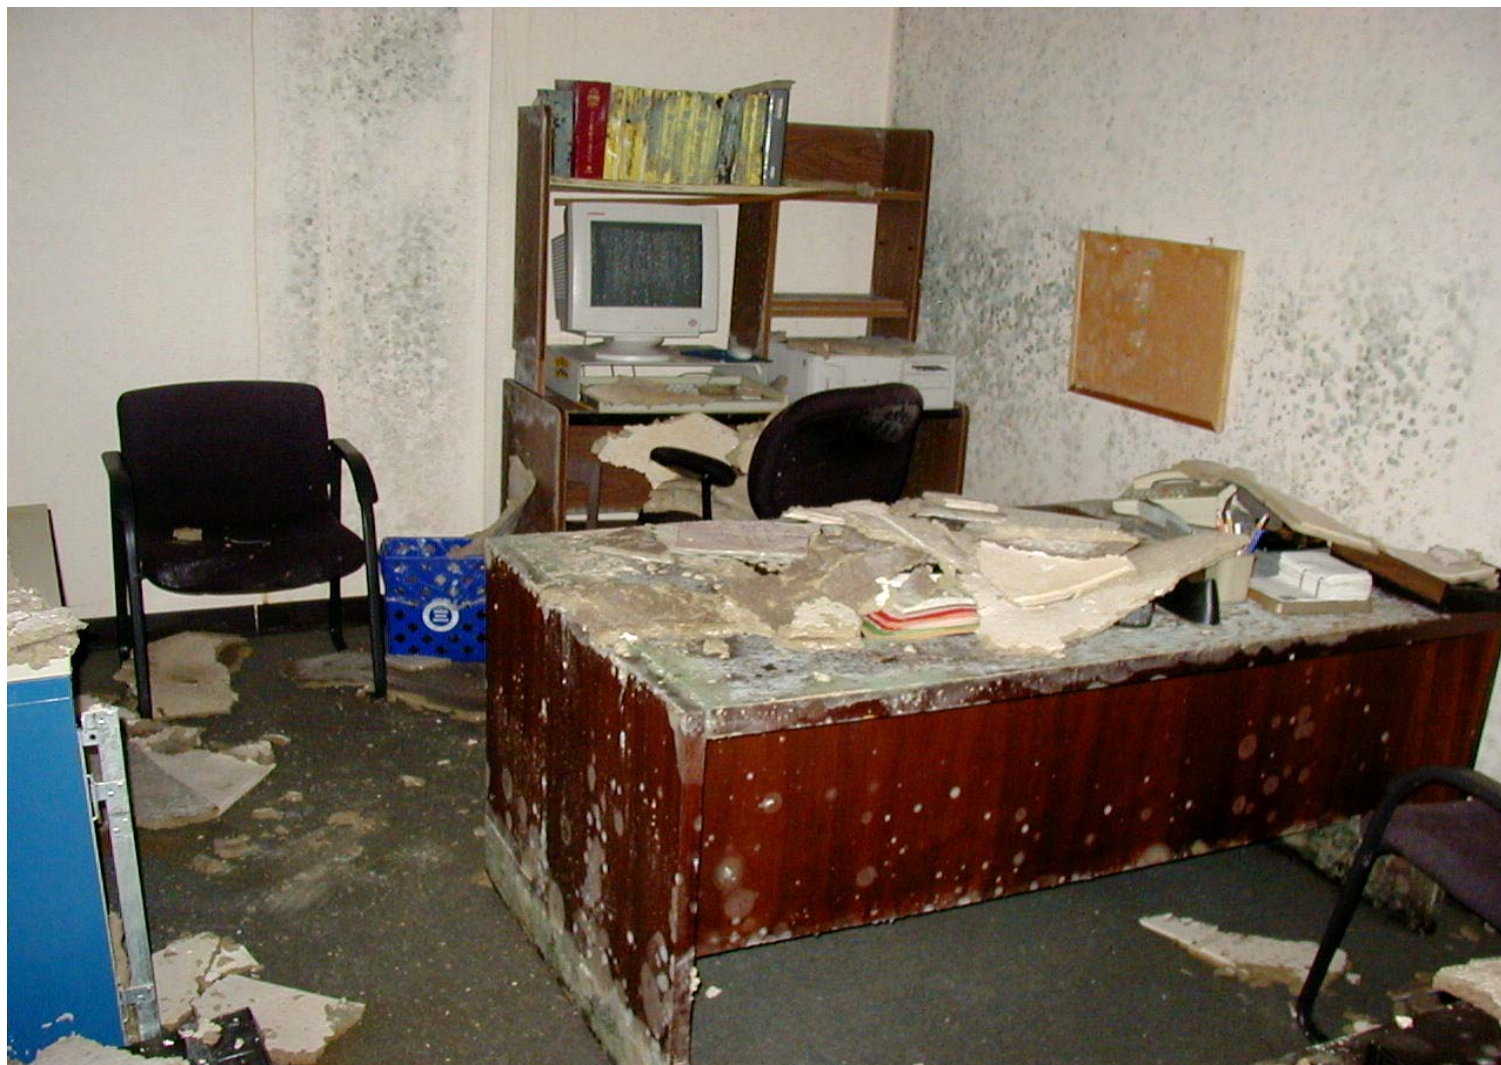
Basement office after flood - 3 weeks mold growth

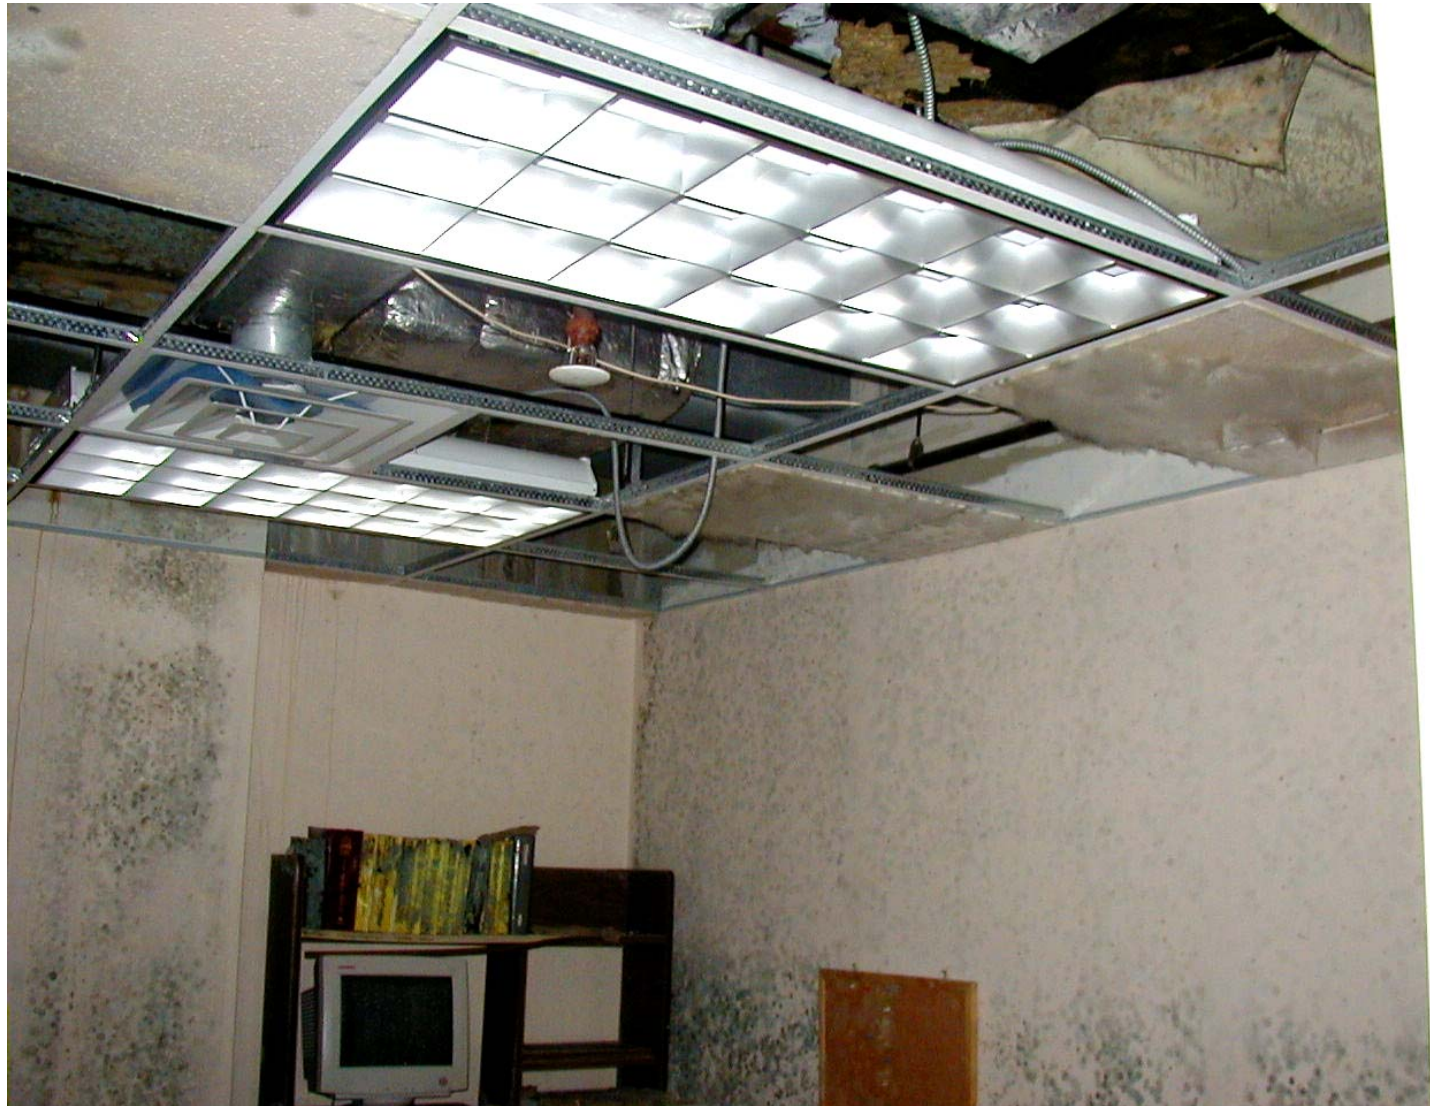
Mold growth on walls and above ceiling - 3 weeks

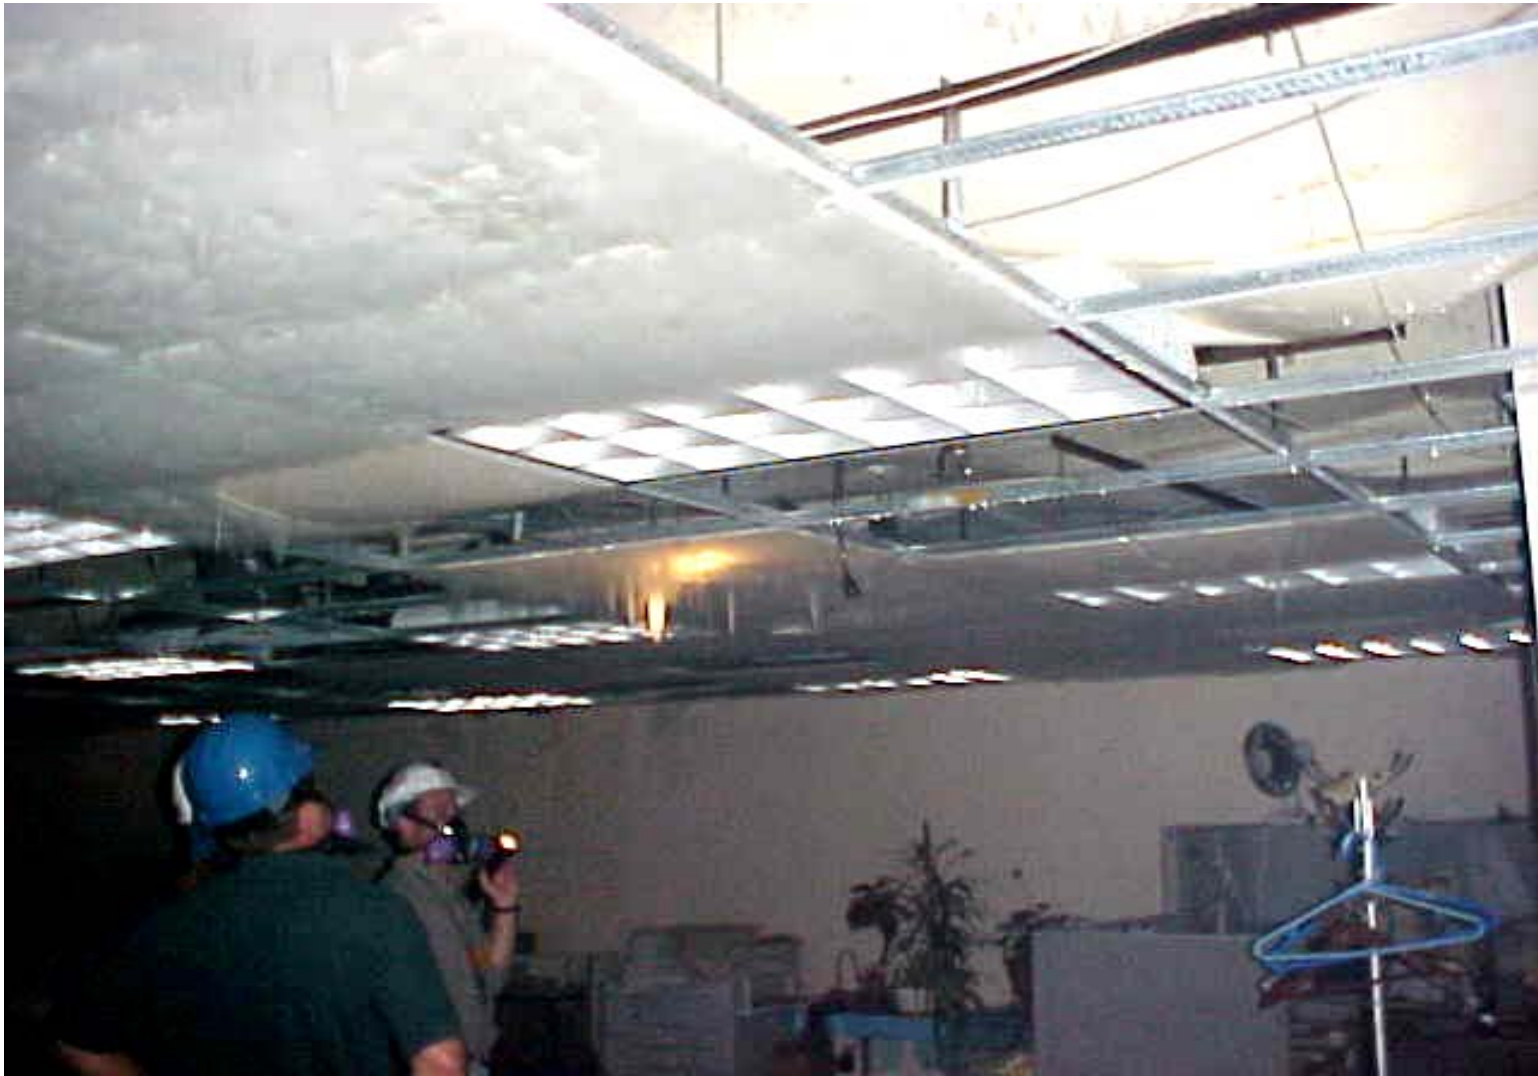
Extreme mold growth in a basement - 6" "fuzz" on ceiling

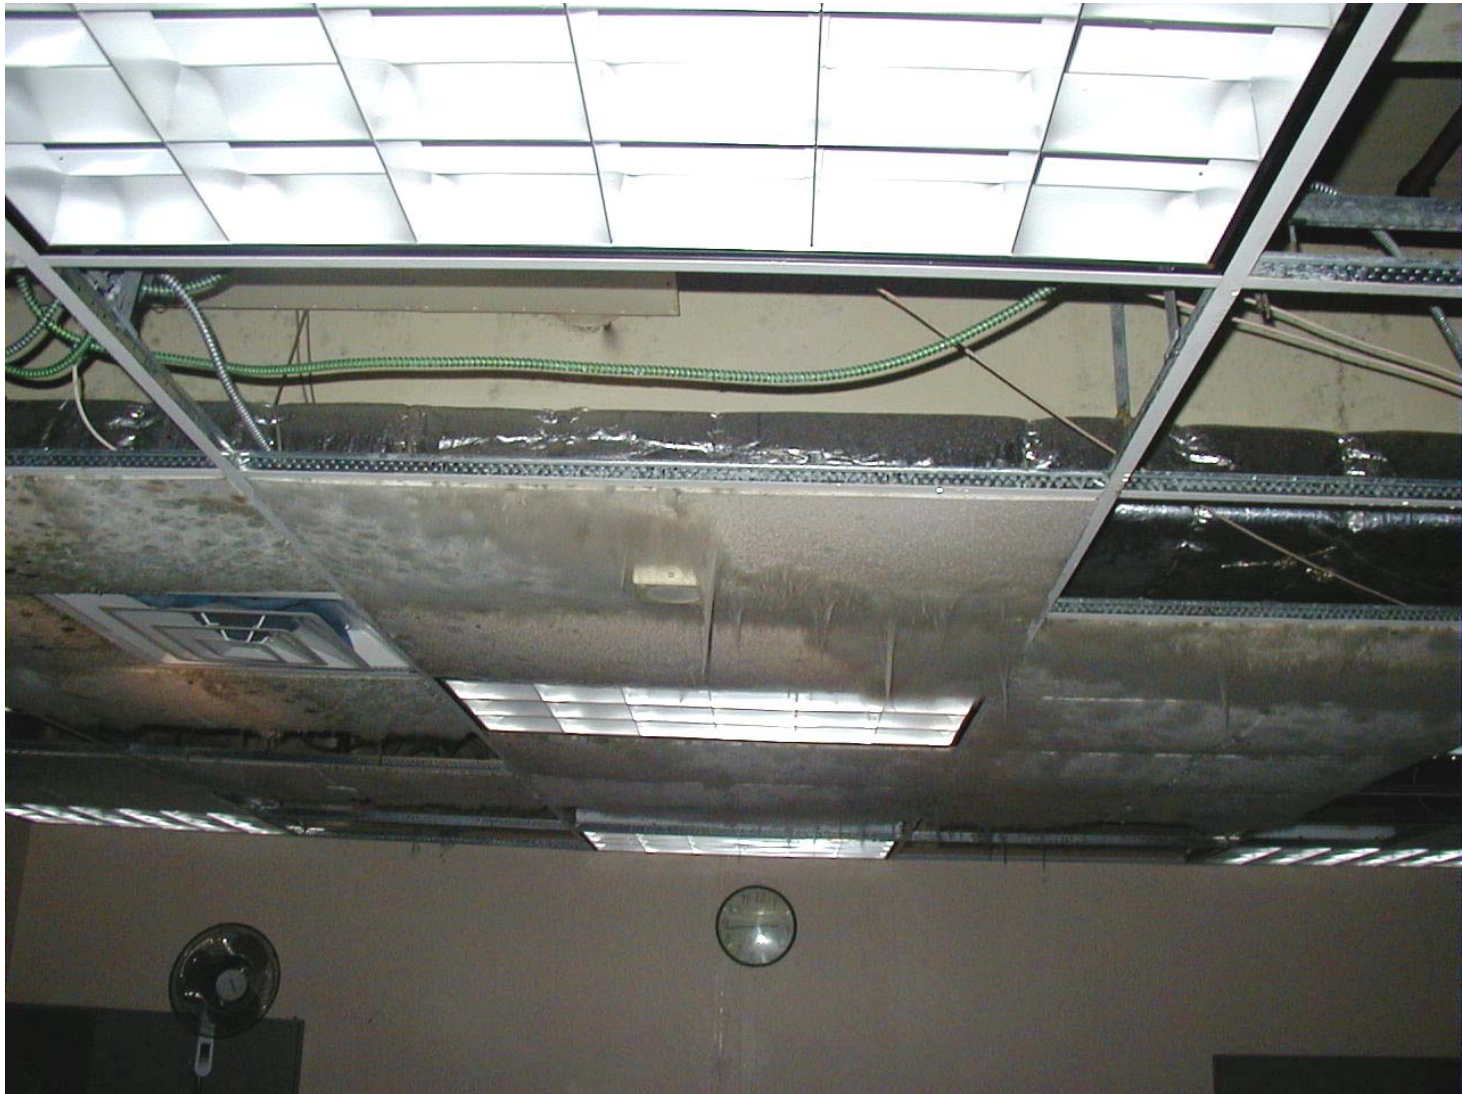
Mold Growth on Ceiling - 3 weeks

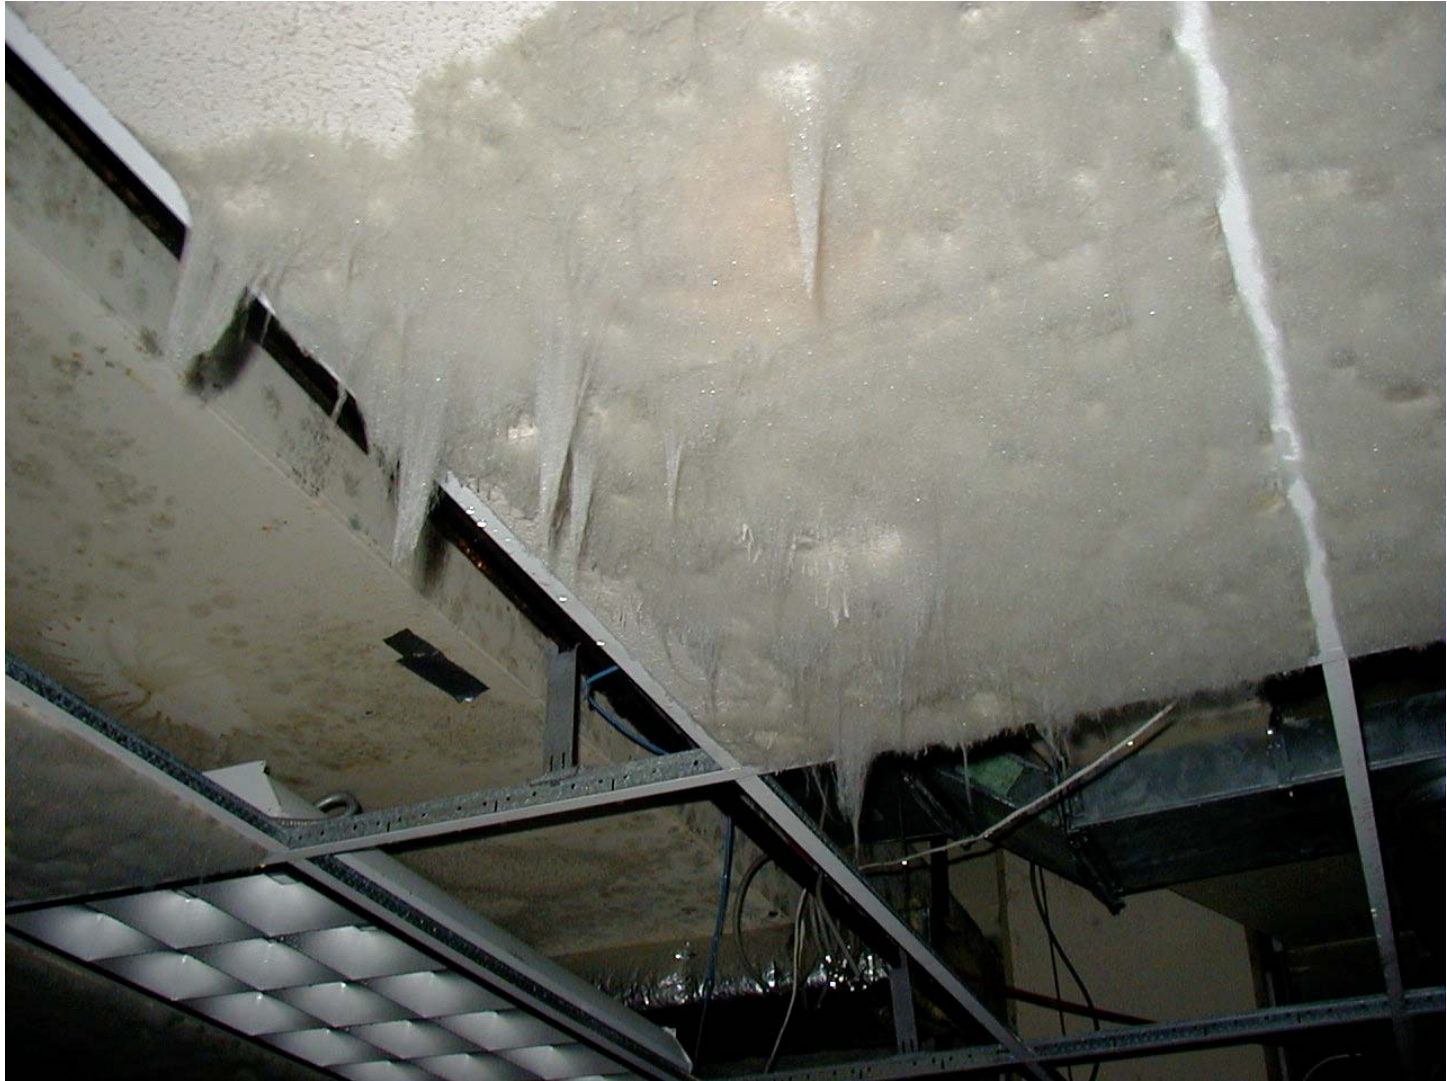
Mold Growth - “woolly” appearance visible

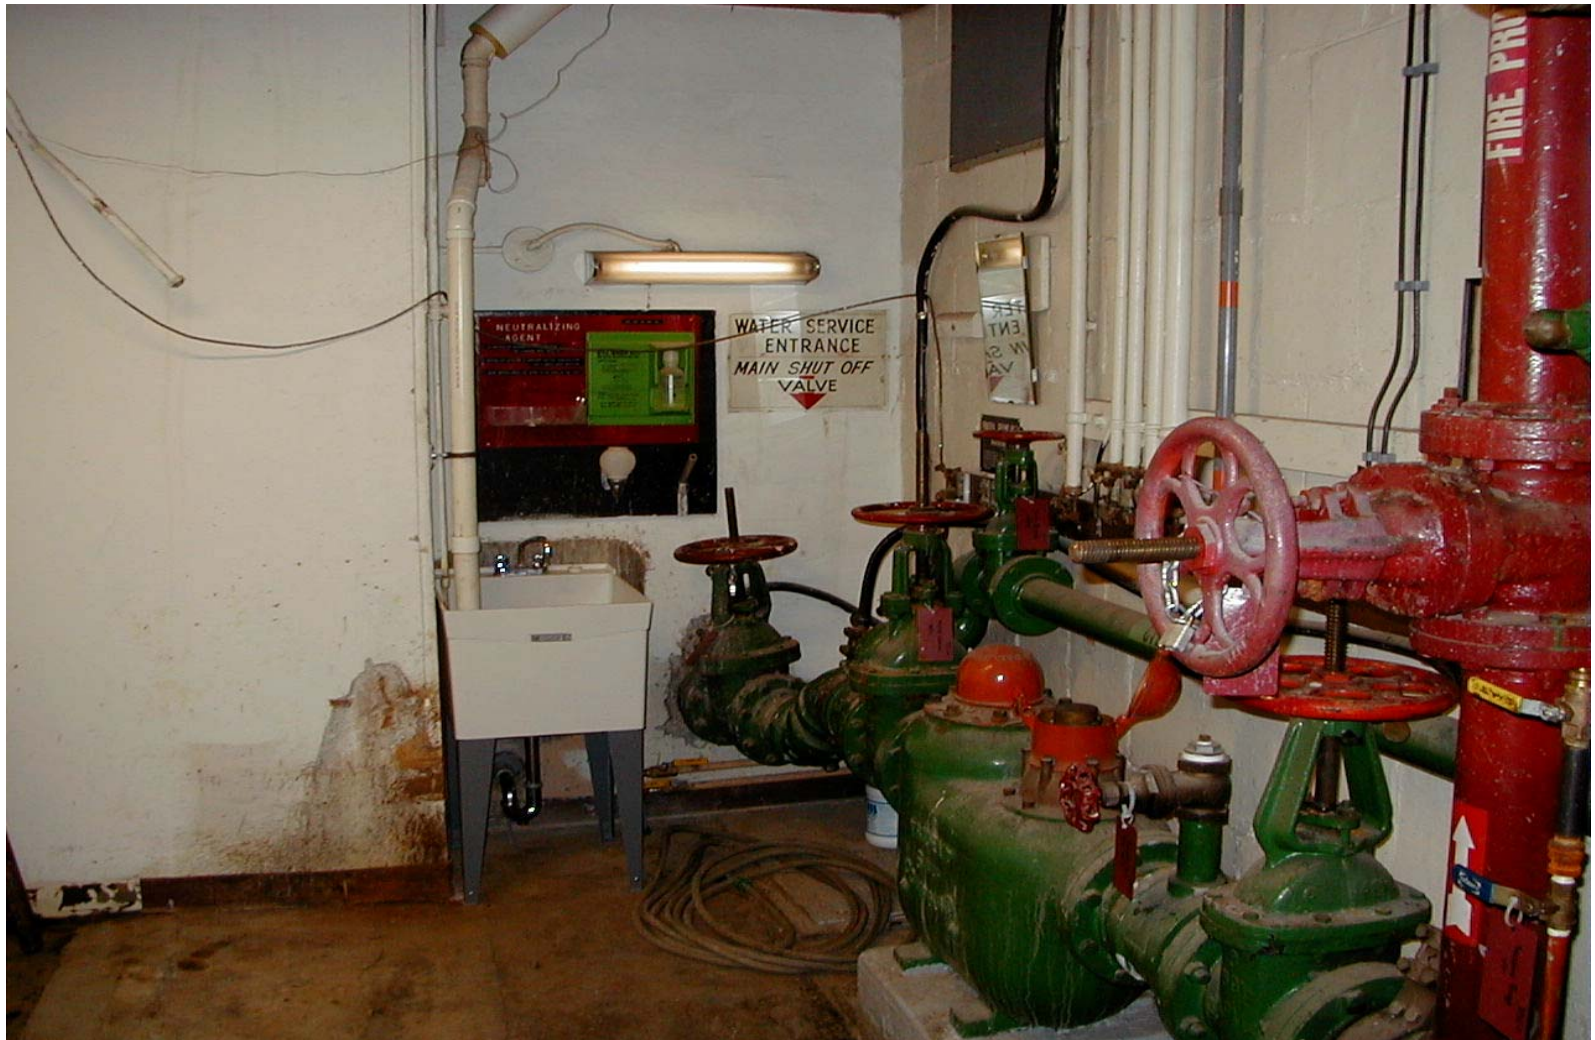
Localized mold growth that can be cleaned in-house
